# **INDOOR AIR QUALITY ASSESSMENT**

**Winthrop Middle School  
151 Pauline Street  
Winthrop, Massachusetts**

Prepared by:  
Massachusetts Department of Public Health  
Bureau of Environmental Health  
Indoor Air Quality Program  
January 2013

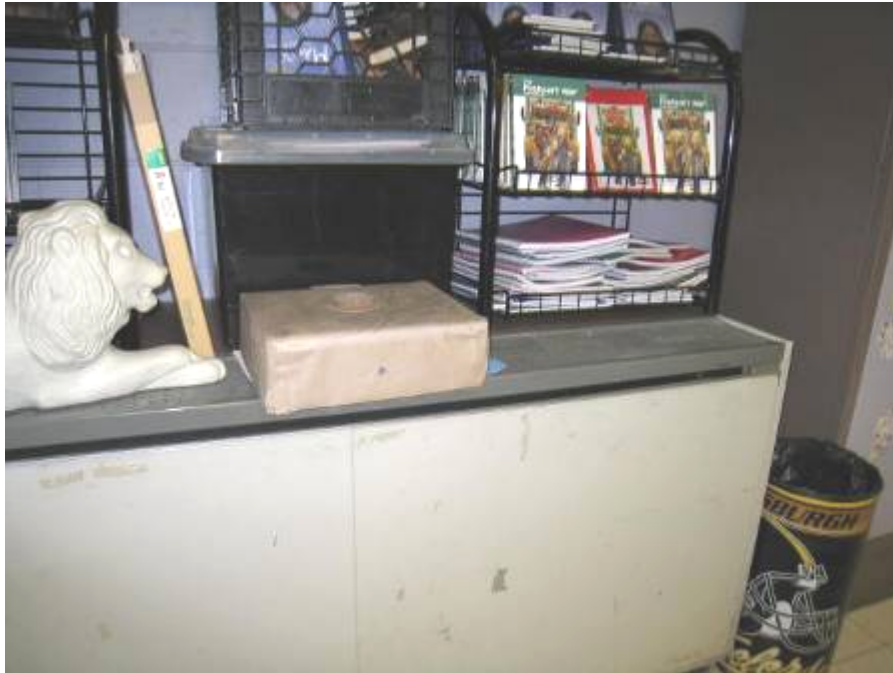
**Picture 1**

Fresh air to exterior classrooms is supplied by unit ventilator (univent) systems (Picture 1). A univent draws air from the outdoors through a fresh air intake located on the exterior wall of the building (Picture 2). Return air from the classroom is drawn through an air intake located at the base of the unit ([Figure 1](#)). Fresh and return air are mixed, filtered, heated and provided to

**Typical univent, note items on top**

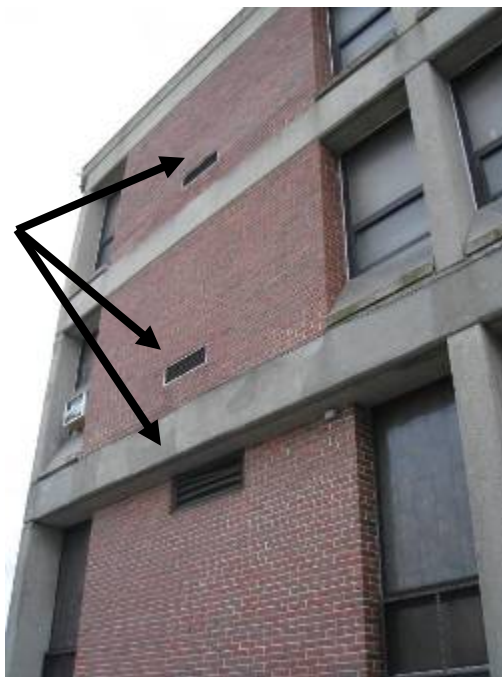
**Picture 2**

**Univent fresh air intakes (arrows)**

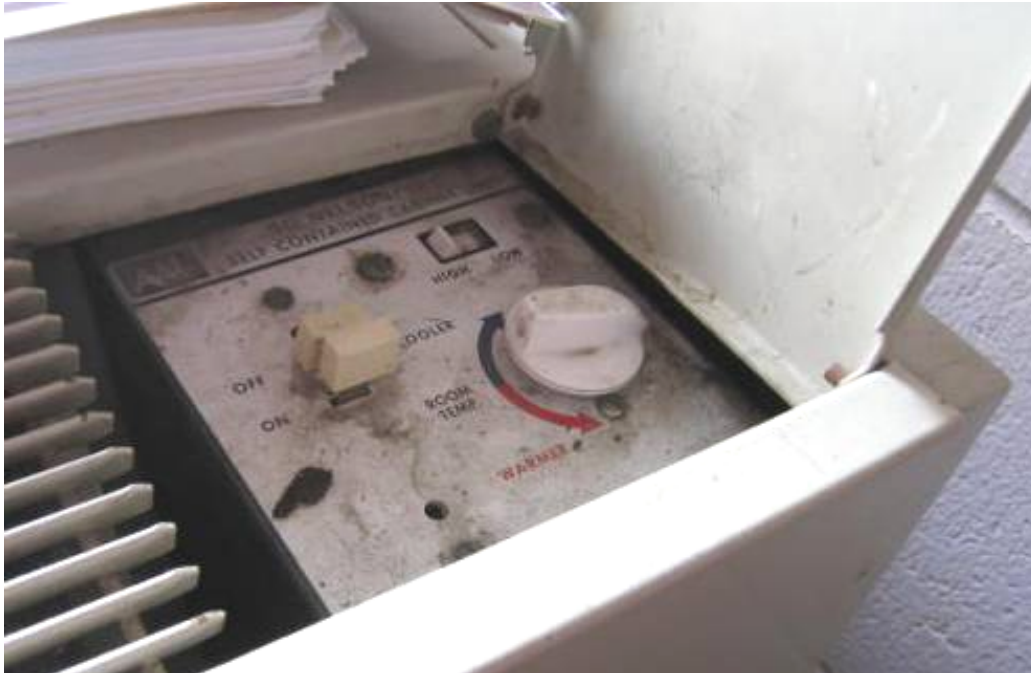
**Picture 3**

classrooms through an air diffuser located in the top of the unit. As mentioned, the majority of univents were found deactivated at the time of assessment (Picture 3; Table 1). In addition, some univents were found obstructed by furniture and other items on top of air diffusers and/or in front of return vents along the bottom of the units (Picture 1). Some univent covers were ajar (Picture 4), compromising filtration. In order for univents to provide fresh air as designed, they must remain “on” and operating while rooms are occupied and remain free of obstructions.

**Univent controls, showing unit is shut off**

1. Operate all ventilation systems throughout the building including univents and interior classroom HVAC systems continuously during periods of occupancy to maximize air exchange. This is of critical importance given the high levels of carbon dioxide documented in numerous areas of the school.
2. Consult with an HVAC engineering firm regarding the feasibility of repair vs. replacement of ventilation system components given their age. In the interim, work with

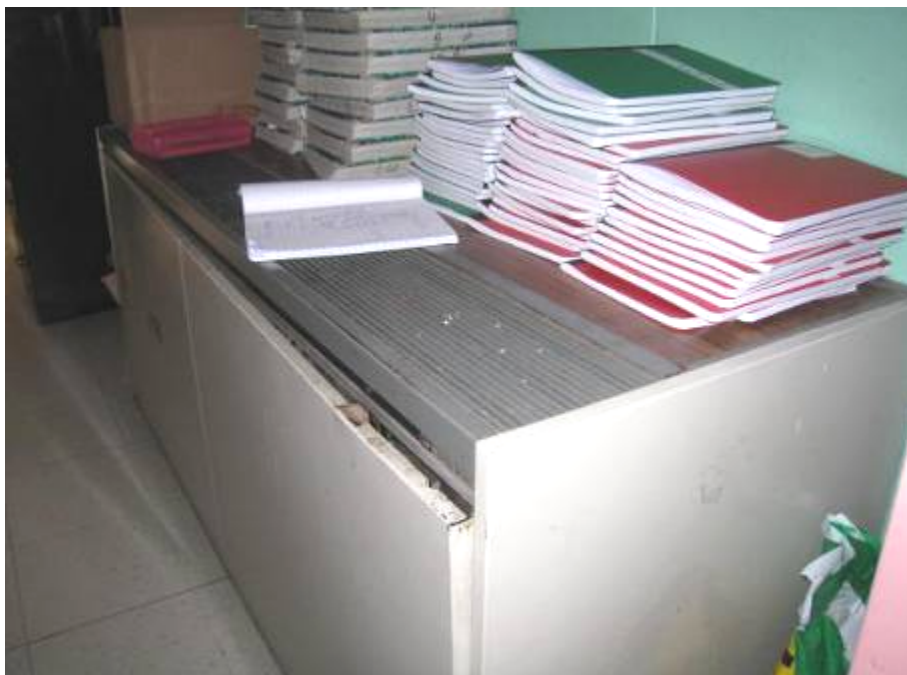
**Picture 4**

**Univent with cover ajar**

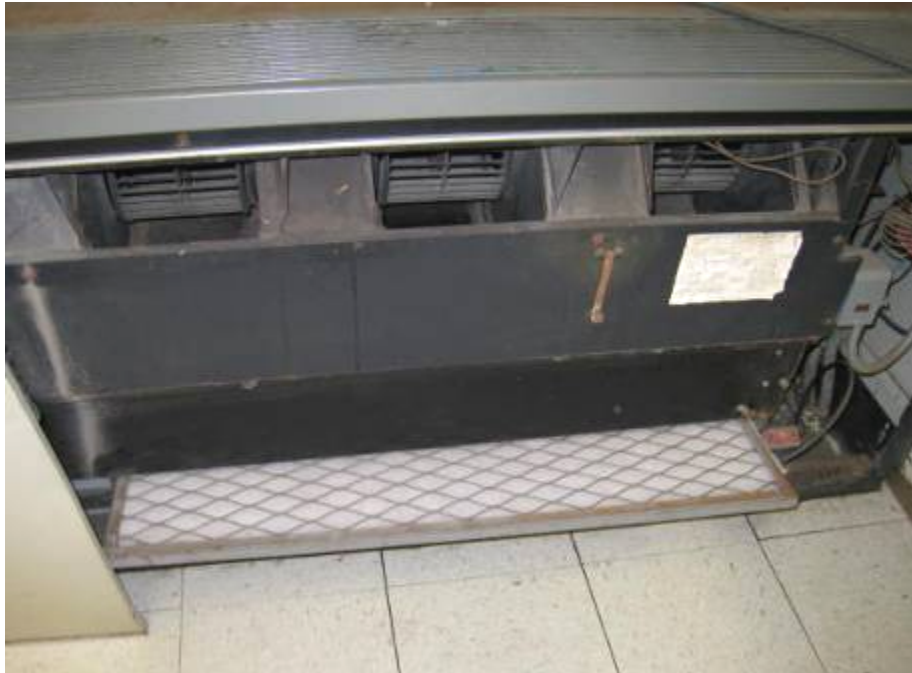
**Picture 5**

The type of filter medium used by the school comes in a bulk roll and must be cut to size before it is inserted into a metal lattice “cage” (Picture 5). This method is extremely time intensive, and the results are variable. If the filter medium is not properly fitted, gaps can allow unfiltered air into the room and/or reduce the useful life of the unit. Disposable filters with an appropriate dust spot efficiency and similar cost can be installed in univents. The dust spot efficiency is the ability of a filter to remove particulates of a certain diameter from air passing through the filter. Filters that have been determined by the American Society of Heating, Refrigeration and Air-Conditioning Engineers (ASHRAE) to meet its standard for a dust spot efficiency of a minimum of 40% would be sufficient to reduce airborne particulates (MEHRC, 1997; ASHRAE, 1992). Note that increased filtration can reduce airflow produced by an air handling unit (AHU) or univent due to increased resistance. Prior to any increase of filtration, each unit should be evaluated by a ventilation engineer as to whether it can maintain function with more efficient filters.

**Open univent showing filter material in lattice “cage”**

4. Consider replacing metal filter racks with proper fitting disposable filters with an equal or greater dust-spot efficiency to eliminate the time needed to replace filters from bulk material rolls. Prior to any increase of filtration, each piece of air handling equipment should be evaluated by a ventilation engineer as to whether it can maintain function with more efficient filters. The time saved through this measure may allow an increased frequency of filter changes; changing filters at least twice a year is recommended.

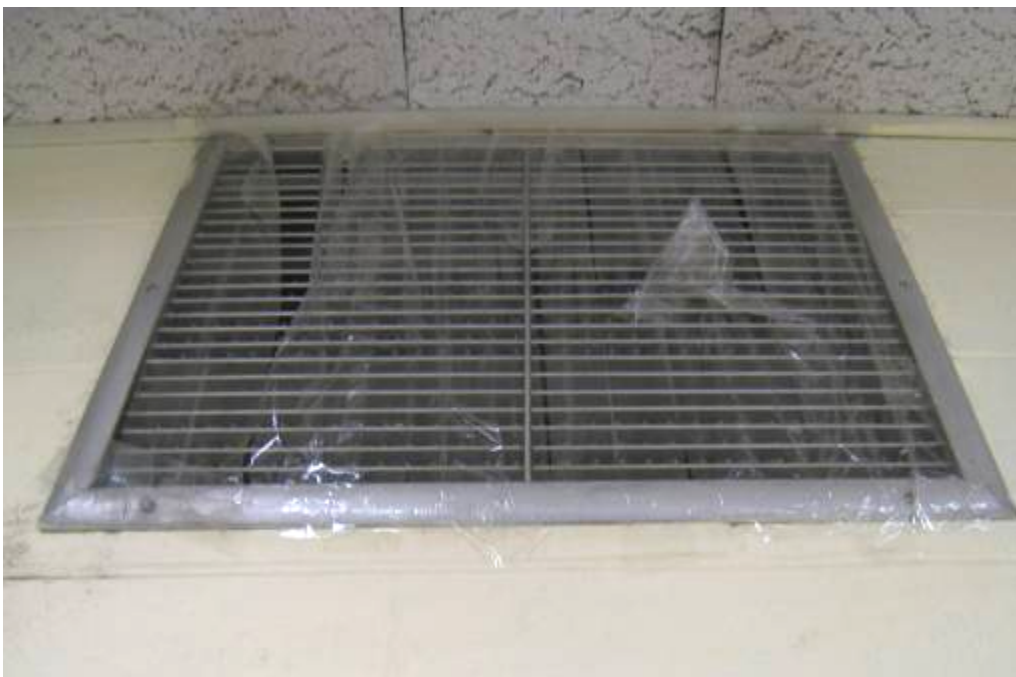
**Picture 6**

**Vent sealed with plastic tape**

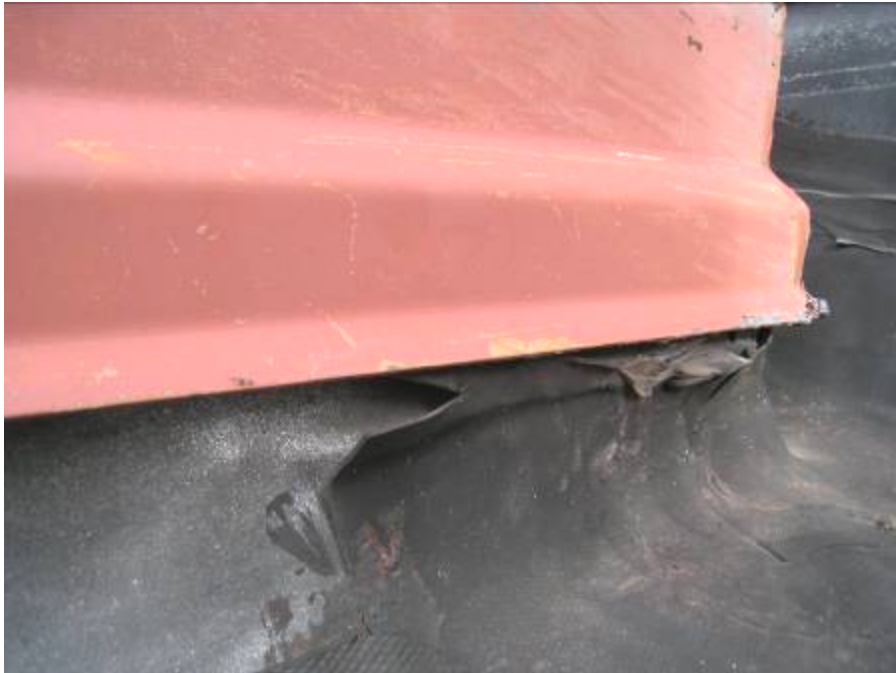
**Picture 7**

Water leaks from the roof were reported in hallways and some classrooms. Additional leaks from plumbing were also reported in lower level classrooms, including room 6A. BEH/IAQ staff noted damage to the flashing/sealing material around the rooftop access hatch and other junction areas on the roof (Picture 7). Repairs to these areas should prevent further

water infiltration. Consideration should also be given to replacing the current roof, which was installed over 15 years ago and is nearing its end of useful service life.

**Damaged sealing material around rooftop access hatch**

8. Ensure roof flashing/junctions and plumbing leaks are repaired and replace any remaining water-damaged ceiling tiles and wall materials. Examine the area above these tiles for mold growth. Disinfect areas of water leaks with an appropriate antimicrobial, as needed.

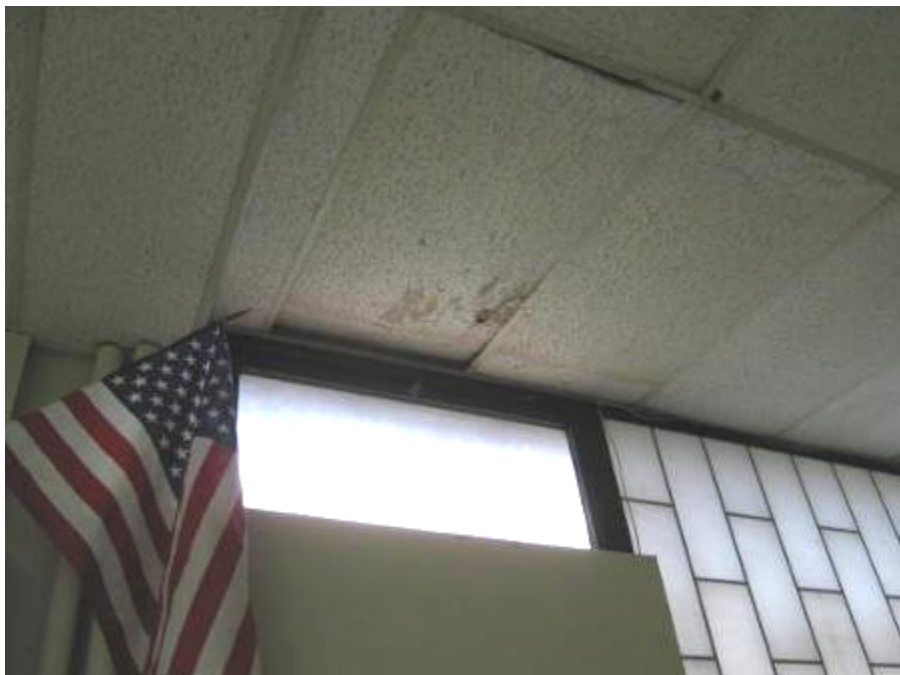
**Picture 8**

Water-stained and missing ceiling tiles were observed in some classrooms (Picture 8). In some areas, water-damaged tiles were the interlocking mineral variety, which can be difficult to replace. These interlocking mineral tiles may also contain asbestos mastic (Picture 9). A determination should be made concerning whether these tiles contain asbestos. If they do, the tiles should be left in place until they can be removed by a licensed asbestos remediation contractor.

**Water-damaged ceiling tiles in room 6A**

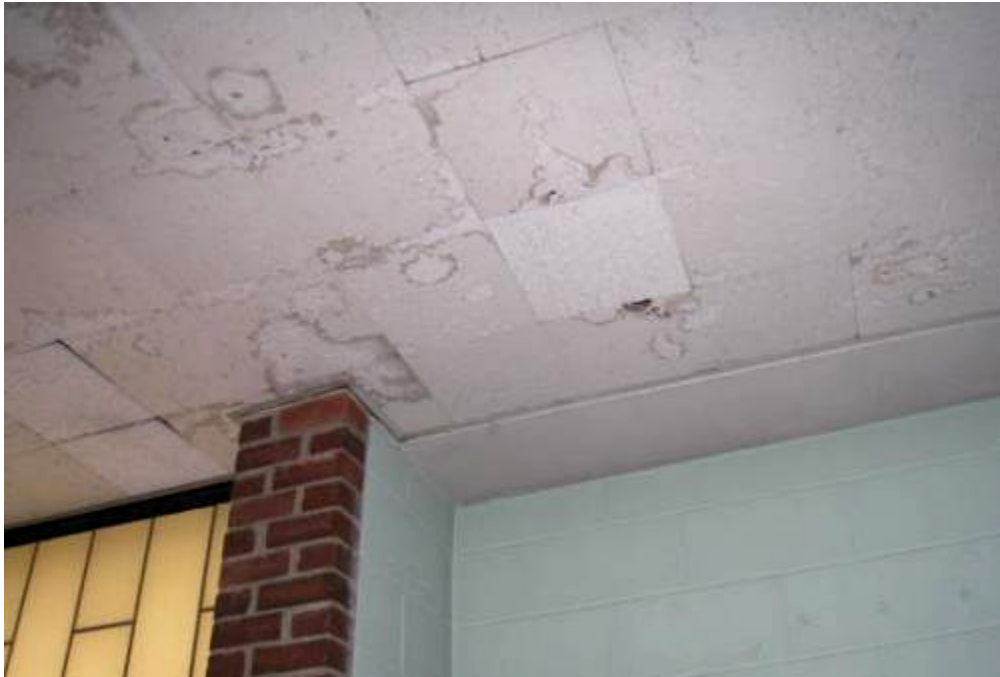
**Picture 9**

**Water-damaged interlocking ceiling tiles**

9. Determine whether interlocking ceiling tiles contain asbestos. If so, remediate damaged tiles in conformance with Massachusetts asbestos remediation and hazardous waste disposal laws.

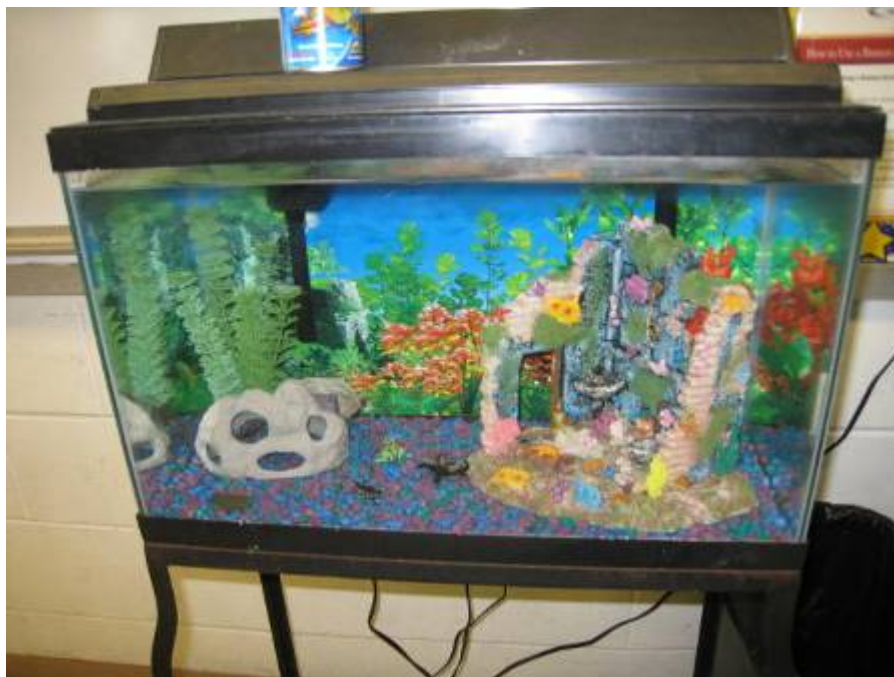
**Picture 10**

**Classroom aquarium**

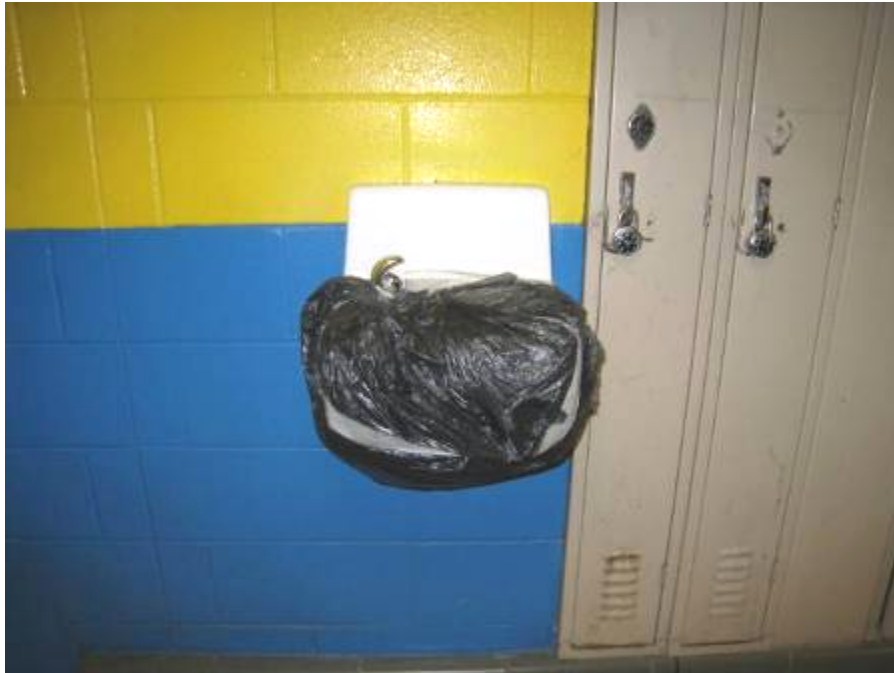
**Picture 11**

Drinking fountains in the main hallways and a toilet in the staff lounge were found to be out of order and covered with plastic (Picture 11). In addition, lab sinks in a science classroom were covered (Picture 12) and the cabinets beneath them were locked. It is not known if the water service to these disused fixtures had been shut off. To prevent both water leaks and the infiltration of sewer gases through unused drains, it is recommended that these fixtures be repaired, if desired, or properly abandoned.

**Out of service water fountain**

12. Repair broken/unused plumbing fixtures or decommission them completely.
13. Ensure plants, trees and shrubs are located at least five feet away from exterior walls/foundation of the building.

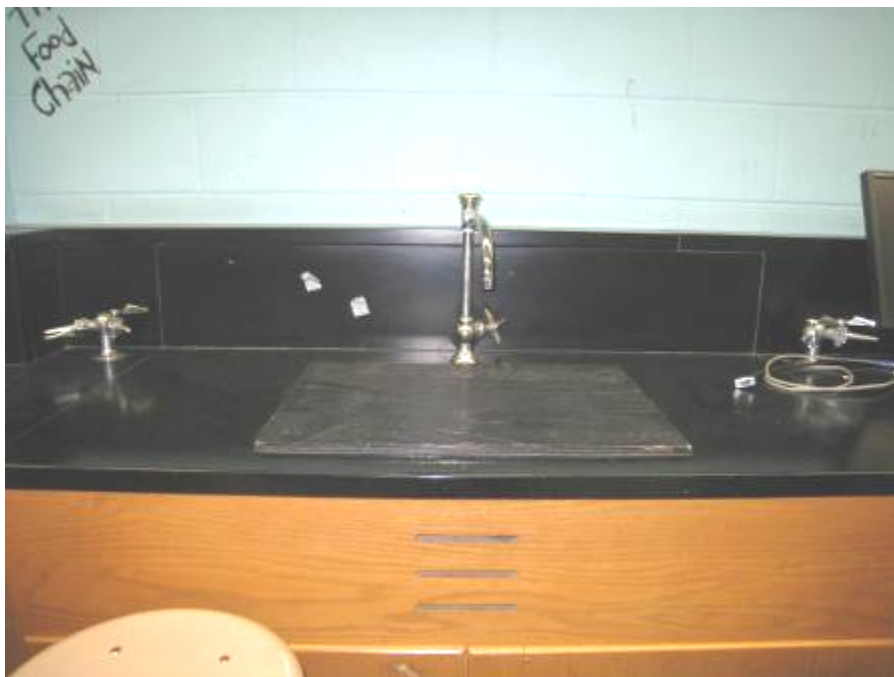
**Picture 12**

**Covered/sealed science lab sink**

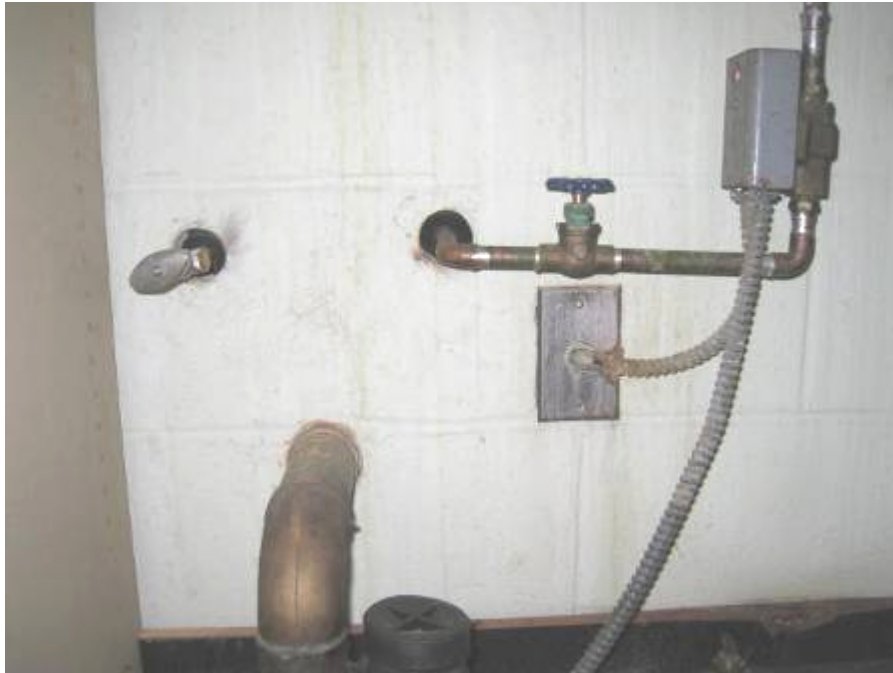
**Picture 13**

but there were several water-damaged ceiling tiles in this room. In addition, there were breaches noted between the areas under sinks and cabinets that open into an unfinished subfloor and wall cavity (Picture 13). These breaches can allow moisture and odors into the occupied space and should be sealed with an appropriate sealant.

**Breaches under sink in room 6A**

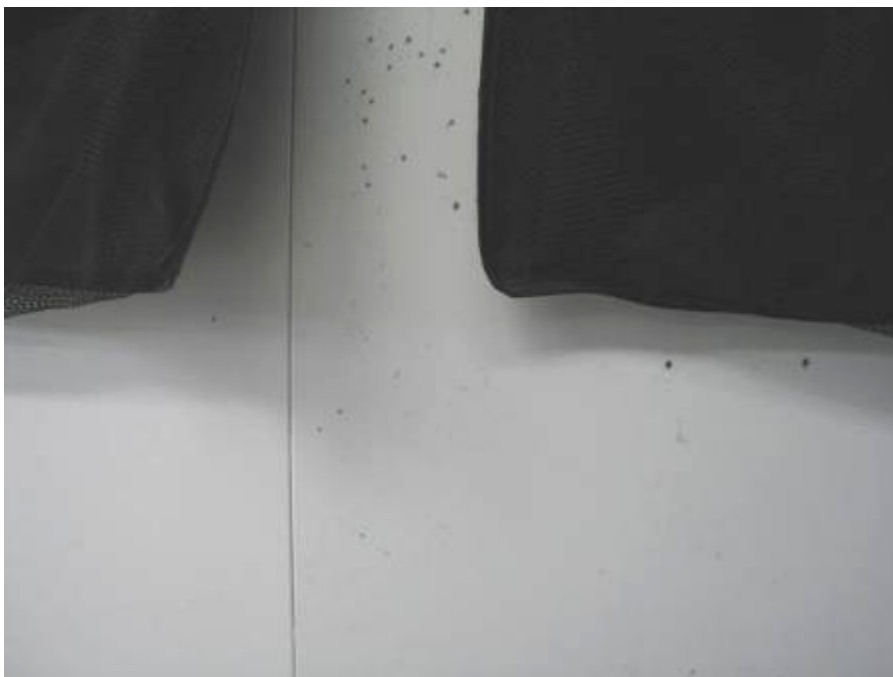
**Picture 14**

There were concerns regarding mold on an interior partition wall between rooms 107 and 109. BEH/IAQ staff examined the area of concern and noted dots of black staining on the wall underneath a large fabric wall hanging (Picture 14). It was reported that the spots kept reappearing following cleaning and painting. The presence of the wall hanging is likely preventing this area from drying following hot, humid weather, and may be contributing to mold growth. It is recommended that the affected area be thoroughly cleaned with an antimicrobial agent and allowed to dry completely; layers of paint may also need to be scraped off to get at the wall substrate layer. Unlike most of the school, which is composed of cement block and similar materials, these partition walls are composed of organic materials that may support mold colonization if they become and stay moist.

**Black staining/possible mold growth on partition wall**

10. Clean partition wall between rooms 107 and 109 with an antimicrobial agent and allow it to dry completely; layers of paint may also need to be scraped off to get at the wall substrate layer. Consider moving the black fabric wall hanging from this location to prevent this area from accumulating moisture.

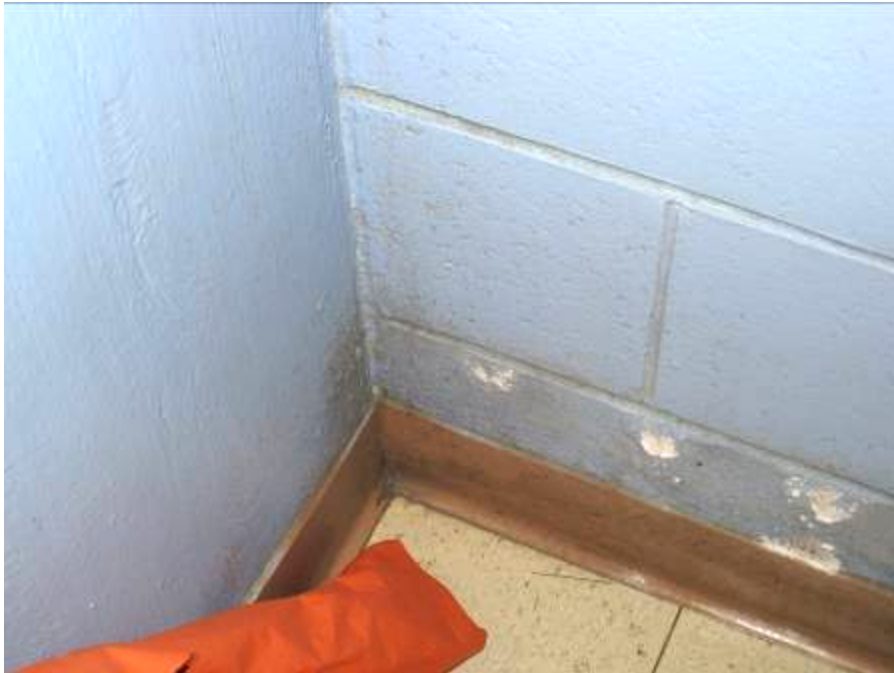
**Picture 15**

Additional concerns were reported regarding the presence of mold in the teachers' room closet. BEH/IAQ staff observed conditions in this closet. A number of items were stored directly on the floor; however, no items appeared to be moist or water-damaged. Dark staining/debris was observed on the cement walls, particularly at the corners where the walls and floor meet (Picture 15). Cement is a semi-porous material that is not a source of mold growth,

and no signs of water damage (e.g. efflorescence) were noted on these walls. The paint applied to the walls also does not support mold growth. Given the location and concentration of the dark material, it is likely that the debris collected in the uneven surface of the cement walls stems from dirt suspended on a mop. Measures should be taken to clean the walls thoroughly to remove the material. Floors should be cleaned with well-rinsed mops to prevent future build up.

**Staining/dirt on wall in teachers' room closet**

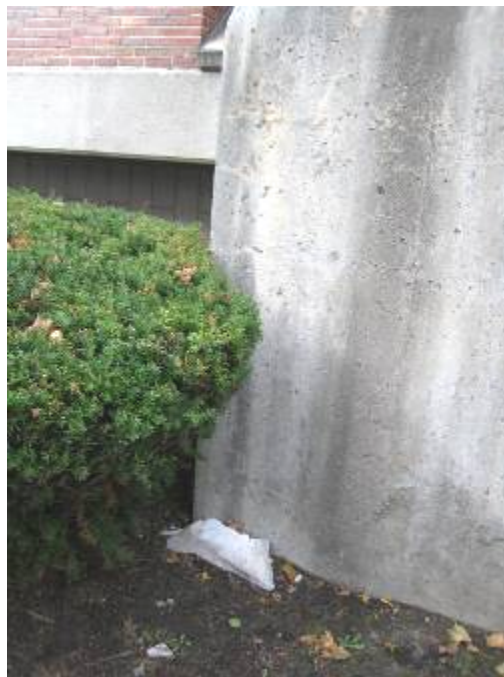
**Picture 16**

During an examination of the exterior of the building, BEH/IAQ staff observed trees and shrubs in close proximity to the building (Picture 16). Shrubs/trees in close proximity to the building hold moisture against the building exterior and prevent drying. The growth of roots against exterior walls can bring moisture in contact with the foundation. Plant roots can eventually penetrate the wall, leading to cracks and/or fissures in the sublevel foundation. Over time, these conditions can undermine the integrity of the building envelope and provide a means of water entry into the building via capillary action through exterior walls, foundation concrete and masonry (Lstiburek & Brennan, 2001). The freezing and thawing action of water during the winter months can create cracks and fissures in the foundation that can result in additional penetration points for both water and pests. Trees and shrubs can also be a source of pollen, debris and mold into univents and windows. Consideration should be given to removing landscaping in close proximity to the building so as to maintain a space of 5 feet between shrubbery and the building.

**Shrub next to foundation**

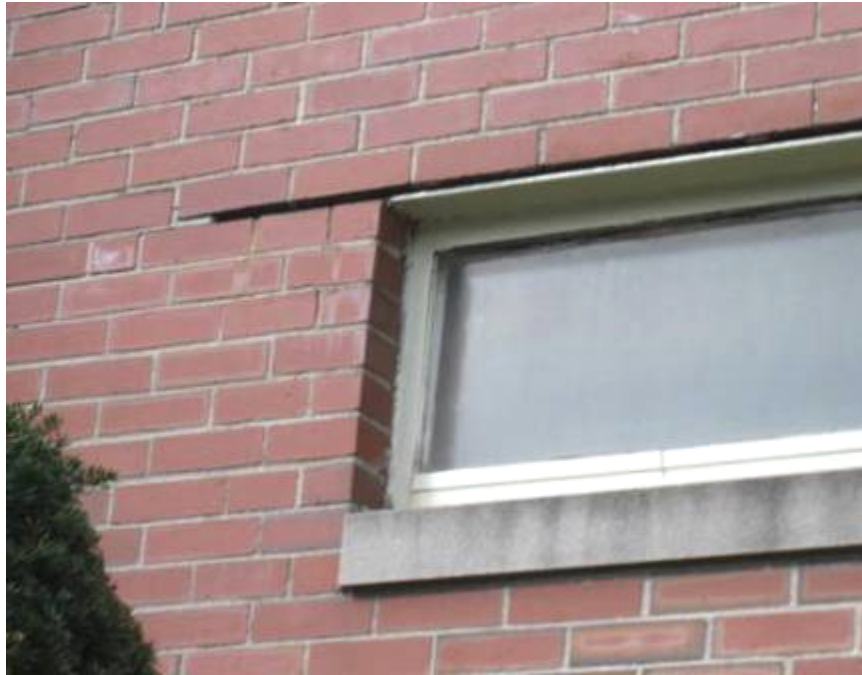
**Picture 17**

There were also cracks/missing mortar observed above windowsills and air intake vents (Picture 17). These cracks may lead to water infiltration during times of wind-driven rain and need to be repaired.

**Missing mortar above window**

14. Repoint cracks and missing mortar on the outside of the building to prevent water infiltration.
15. Ensure indoor plants are equipped with drip pans. Examine drip pans periodically for mold growth and disinfect with an appropriate antimicrobial, as needed. Move plants away from the air stream of mechanical ventilation equipment.

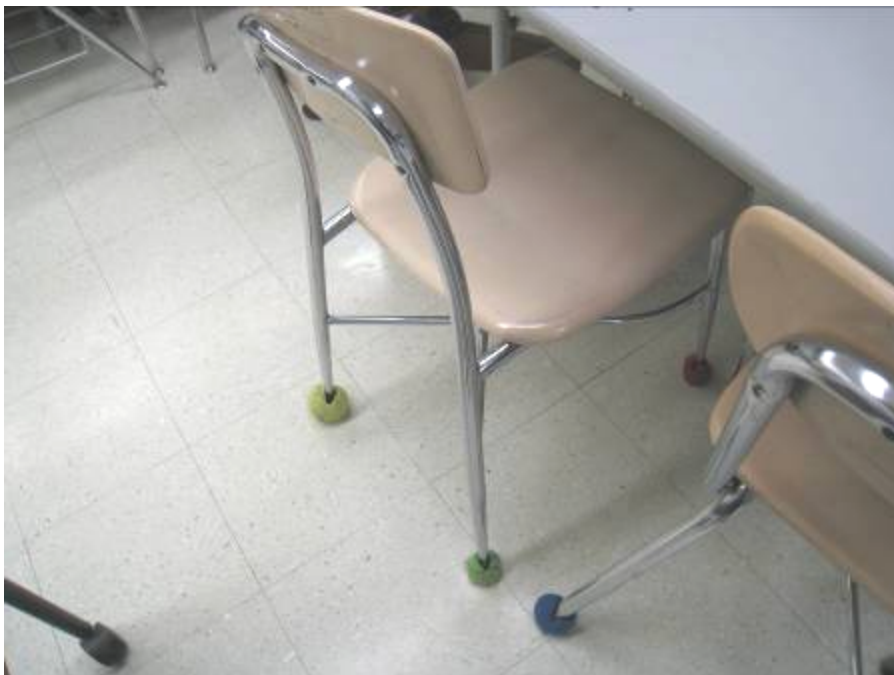
**Picture 18**

In an effort to reduce noise, tennis balls had been sliced open and placed on the base of desk/chair legs in some classrooms (Picture 18). Tennis balls are made of a number of materials that are a source of respiratory irritants. Constant wearing of tennis balls can produce fibers and cause VOCs to off-gas. Tennis balls are made with a natural rubber latex bladder, which becomes abraded when used as a chair leg pad. Use of tennis balls in this manner may introduce latex dust into the school environment. Some individuals are highly allergic to latex (e.g., spina bifida patients) (SBAA, 2001). It is recommended that the use of materials containing latex be limited in buildings to reduce the likelihood of symptoms in sensitive individuals (NIOSH, 1997).

**Tennis balls used as chair glides**

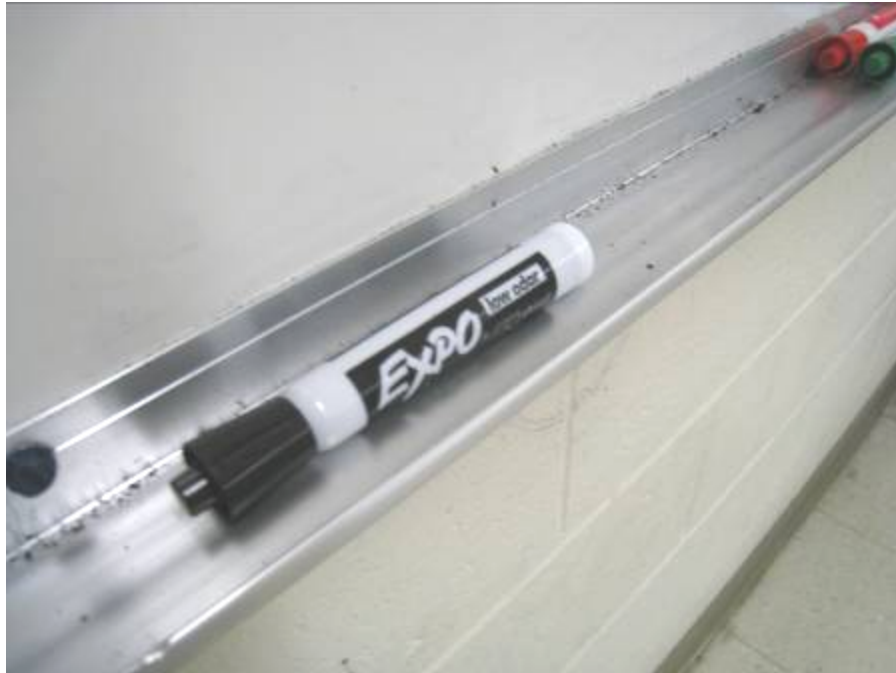
**Picture 19**

**Whiteboard marker debris**

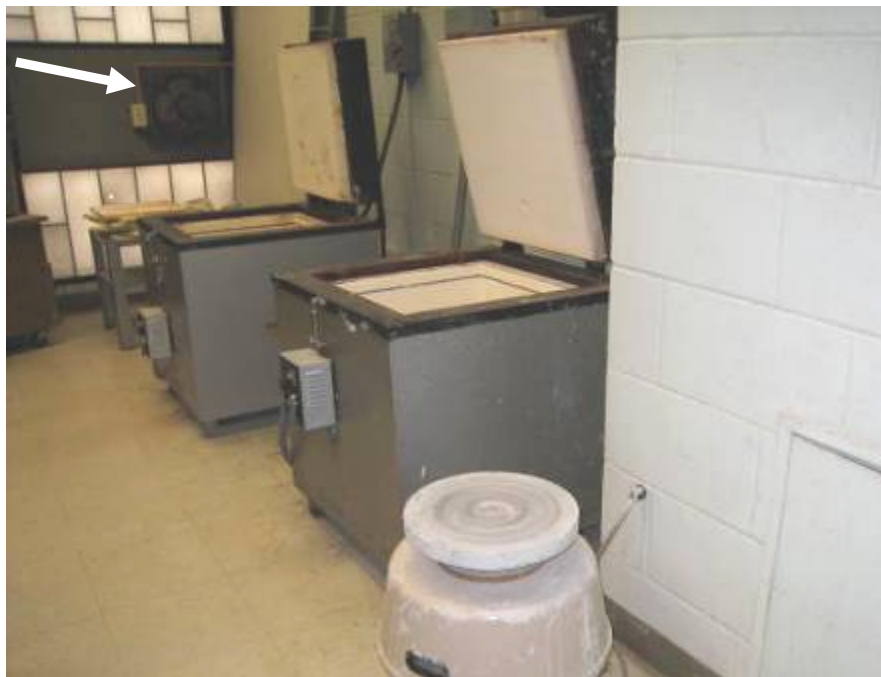
**Picture 20**

Other conditions that can affect indoor air quality were observed during the assessment. In a storeroom adjacent to the art area were two pottery kilns (Picture 20). Pottery kilns can be a significant source of water vapor, particulate and other related pollutants when operating. In addition, a pottery kiln is a source of waste heat that can present a safety/fire hazard. The kilns appeared to be electrically operated, and there was a switch-operated exhaust fan in the wall near but not directly adjacent to the kilns (Picture 21). The kilns were not outfitted with a dedicated exhaust hood, which removes heat and pollutants outside building. In addition, the switch for the exhaust may be difficult to reach when the kilns are in operation, since the switches are located

next to the fan on the wall. Kilns should be vented directly outdoors and kept away from students. Bottles of pottery glazing materials were examined and they were labeled as “lead free”, which is appropriate and recommended to protect the safety and health of staff and students.

**Pottery kilns, note wall-mounted switch-activated exhaust fan several feet away (arrow)**

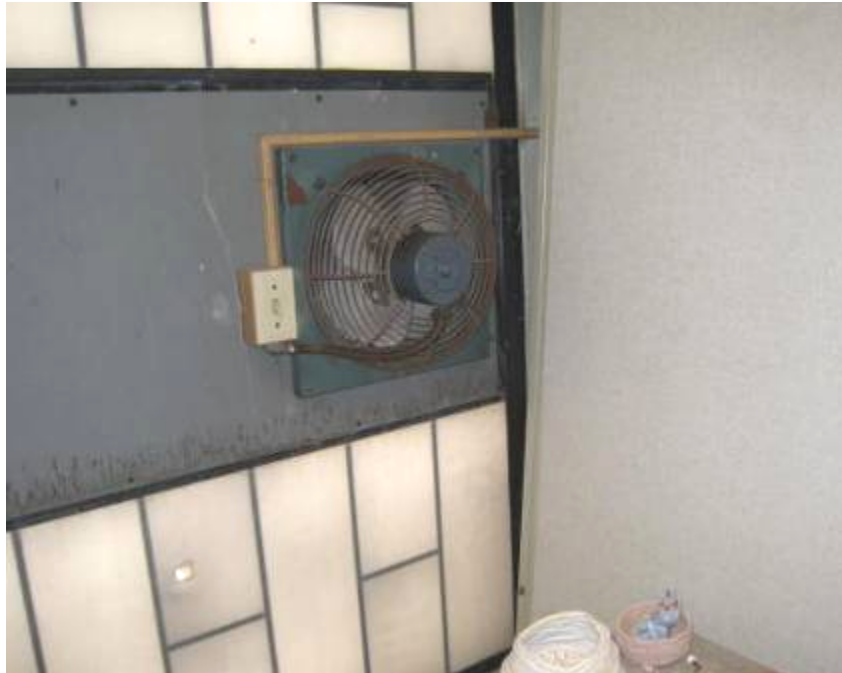
**Picture 21**

**Kiln room exhaust fan with switch**

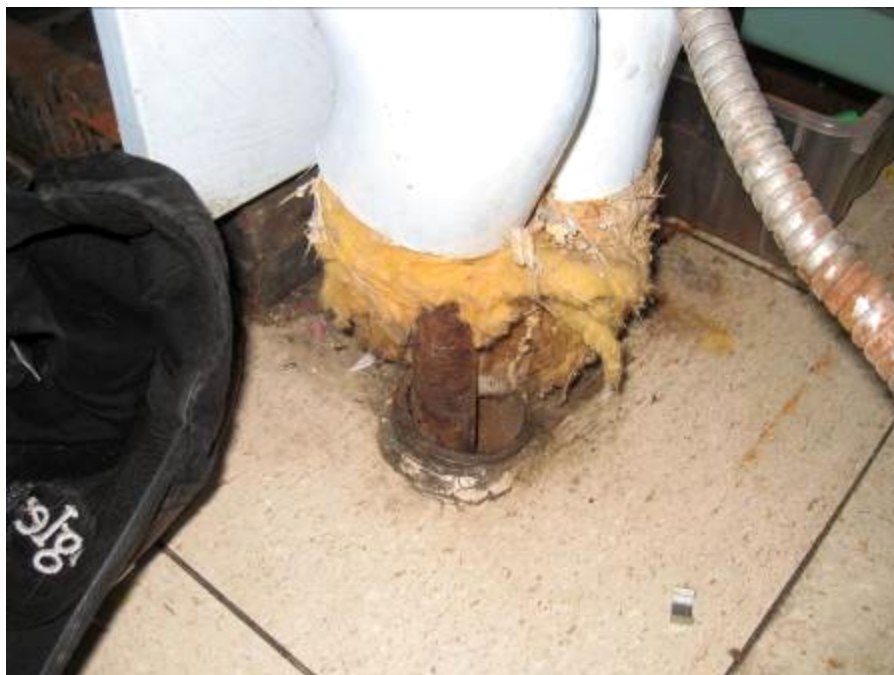
**Picture 22**

Exposed fiberglass insulation was observed around pipes leading into univent cabinets (Picture 22). Fiberglass particles are a source of irritation to the eyes and respiratory system. Pipe wrapping should be examined, and exposed insulation should be re-wrapped to prevent aerosolization of fiberglass materials.

**Exposed fiberglass pipe insulation**

24. Investigate function of marked-out device on ceiling of teachers' lounge and repair or replace as needed.
25. Encapsulate exposed fiberglass insulation around univent pipes in classrooms.

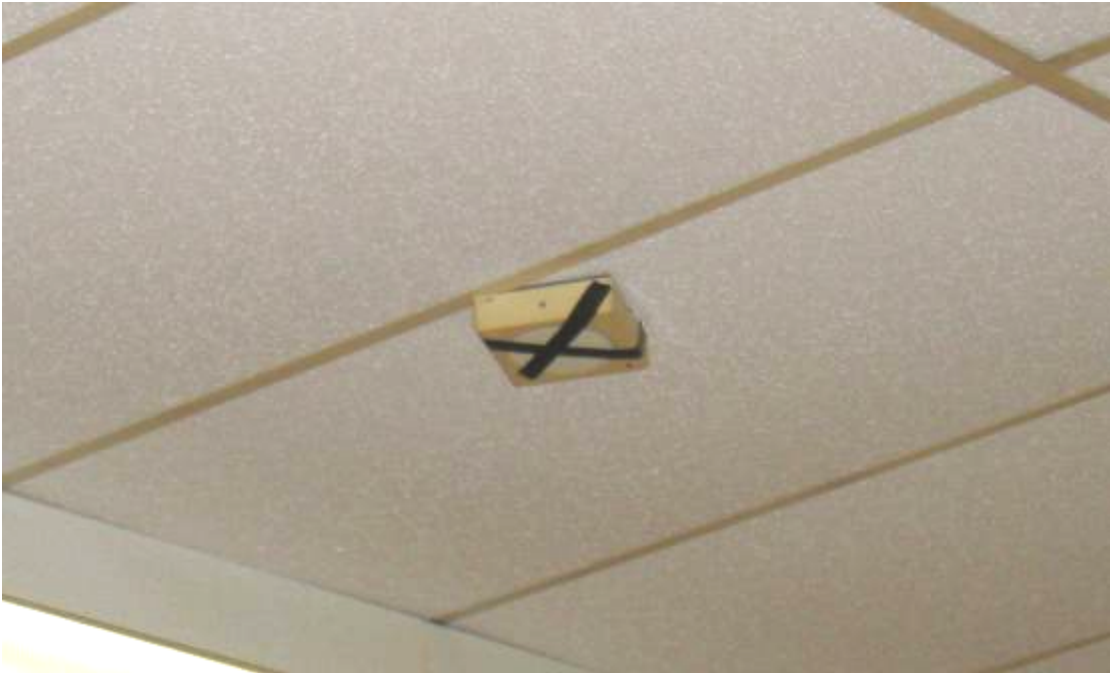
**Picture 23**

Black tape was observed on a device that is likely a fire detector in the teachers' lounge (Picture 23). Measures should be taken to determine whether this unit is operable. If not, this fire detector should be replaced.

**Black tape markings on device on teachers' lounge ceiling**
