# **INDOOR AIR QUALITY REASSESSMENT**

**Winthrop Middle School  
151 Pauline Street  
Winthrop, Massachusetts**

Prepared by:  
Massachusetts Department of Public Health  
Bureau of Environmental Health  
Indoor Air Quality Program  
August 2014

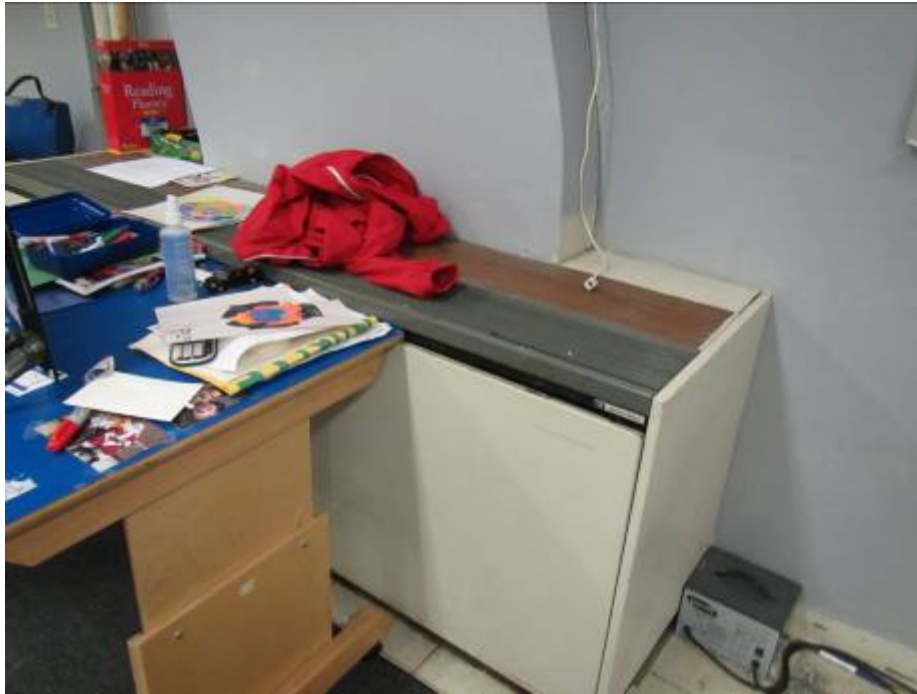
**Picture 1**

Fresh air to exterior classrooms is supplied by unit ventilator (univent) systems (Picture 1). A univent draws air from the outdoors through a fresh air intake located on the exterior wall of the building (Picture 2). Return air from the classroom is drawn through an air intake located at the base of the unit ([Figure 1](#)). Fresh and return air are mixed, filtered, heated and provided to classrooms through an air diffuser located in the top of the unit. As mentioned, the majority of univents were found deactivated at the time of the assessment (Picture 3; Table 1). In addition, some univents were found obstructed by furniture and other items on top of air diffusers and/or in front of return vents along the bottom of the units. Some univent covers were ajar (Picture 1). Other univents had what appeared to be replacement diffusers consisting of a metal panel with holes drilled in it (Picture 4). This non-standard part may not be able to supply adequate fresh air and may also cause backpressure, which can damage the univent. In order for univents to provide fresh air as designed, they must remain “on” and operating while rooms are occupied and remain free of obstructions.

**Typical univent, note obstructions, ajar cover, items on top**

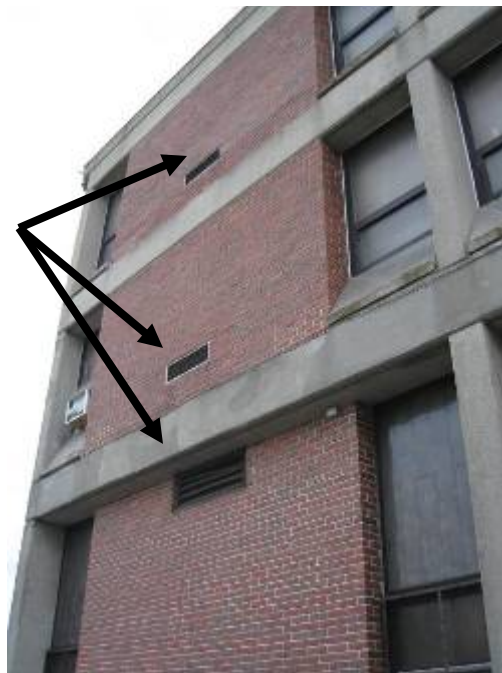
**Picture 2**

**Univent fresh air intakes (arrows)**

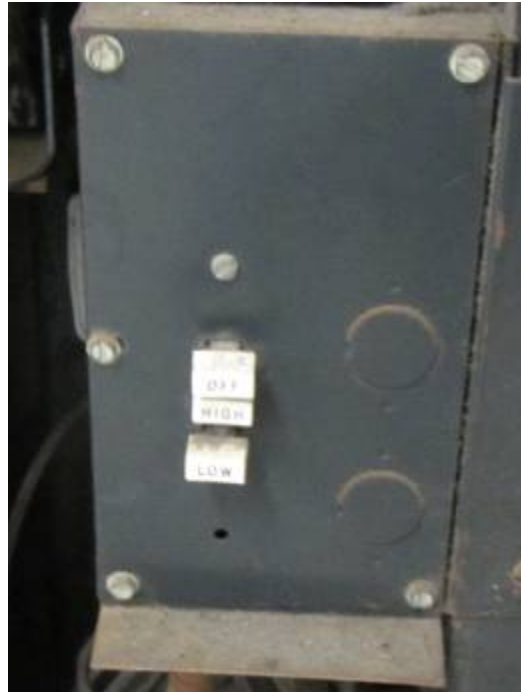
**Picture 3**

**Univent controls, univent is off**

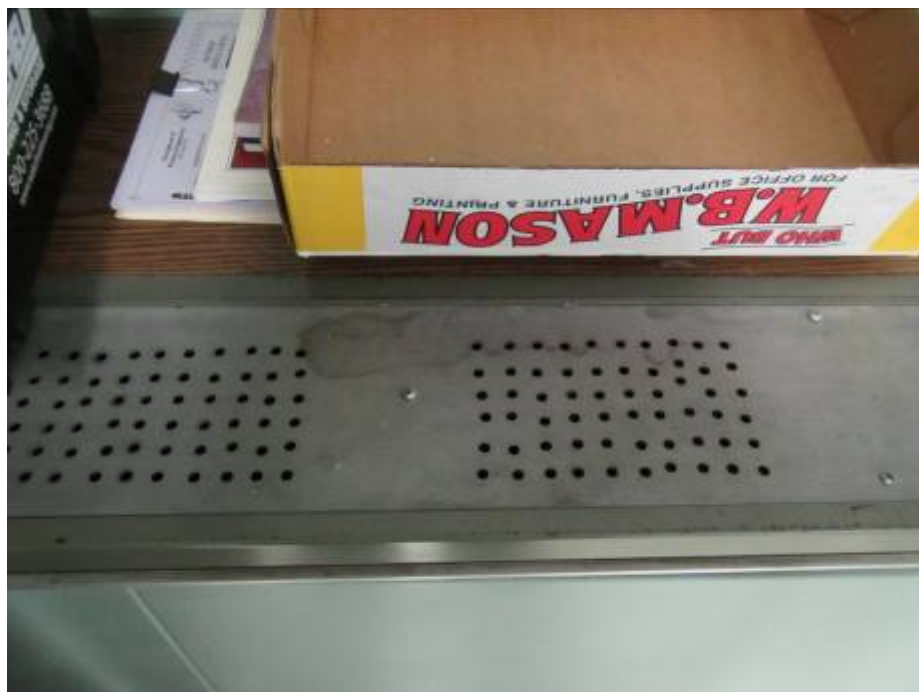
**Picture 4**

**Top of univent showing non-standard replacement diffuser**

3. Consult with an HVAC engineering firm regarding the feasibility of repair vs. replacement of ventilation system components given their age. In the interim, work with an HVAC engineering firm to adjust/repair univents and exhaust vents to improve air exchange in classrooms. This should include replacement of the makeshift air diffusers such as those shown in Picture 4 with standard ones.

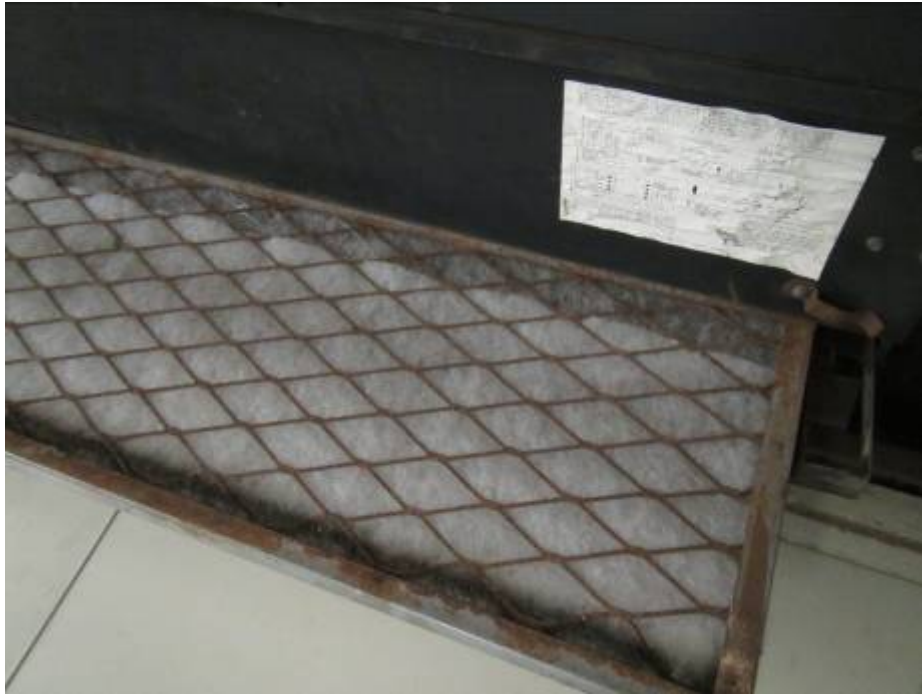
**Picture 5**

**Univent filter medium in lattice cage, note rust/deterioration of cage**

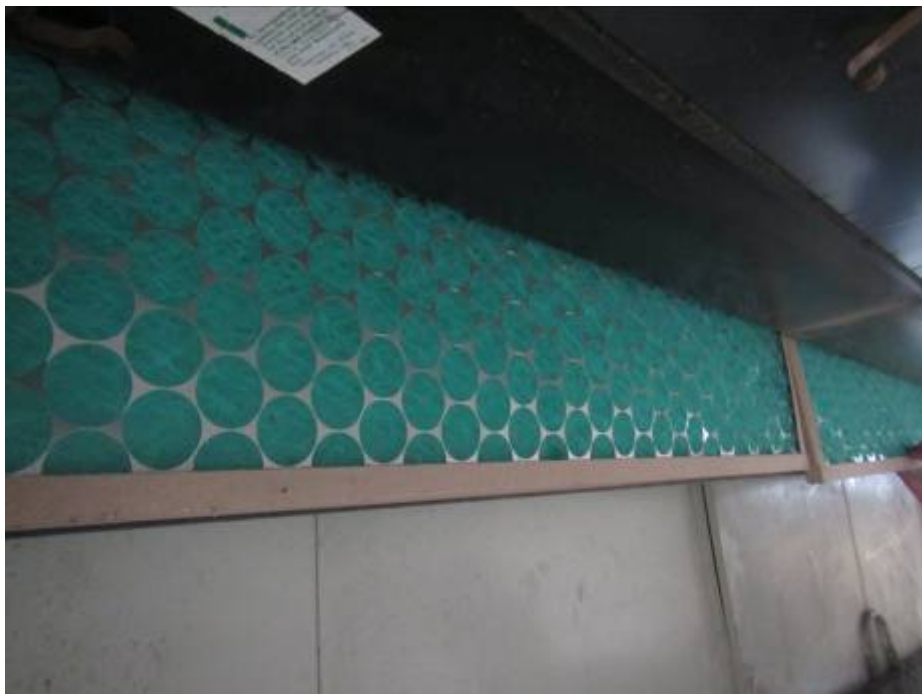
**Picture 6**

its standard for a dust spot efficiency of a minimum of 40% would be sufficient to reduce airborne particulates (MEHRC, 1997; ASHRAE, 1992). Note that increased filtration can reduce airflow produced by an air handling unit (AHU) or univent due to increased resistance. Prior to any increase of filtration, each unit should be evaluated by a ventilation engineer as to whether it can maintain function with more efficient filters. In one of the univents examined, disposable filters were found to be installed, however these were observed to be of a very low efficiency type (Picture 6), which do not remove significant amount of particulates.

**Disposable filter in univent cabinet; this type of filter has a very low dust spot efficiency**

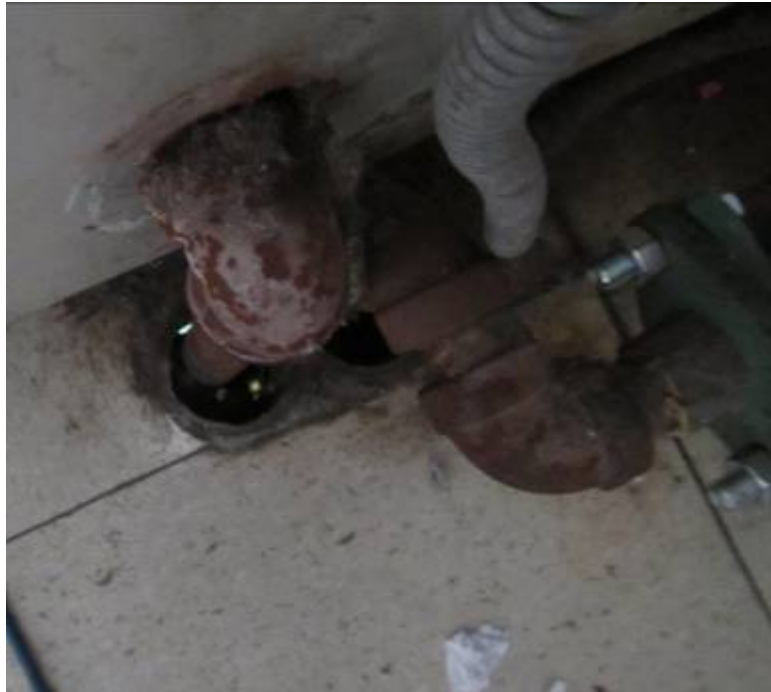
**Picture 7**

Some of the univents examined had dust and debris accumulated inside cabinets and on radiator fins. This material should be removed through vacuuming during regular filter changes. Spaces were also observed around pipes leading to univent cabinets (Picture 7). In addition, some of the gaps in the rear of univent cabinets had been blocked/filled with what appeared to be insulation batting, which is not only ineffective in blocking air through the gaps, but can also be a source of particulates. These gaps should be sealed with an appropriate fire-rated material to prevent the draw of odors and materials from other areas of the building into the univent.

**Pipe to univent cabinet with spaces (see light) around it to floor below**

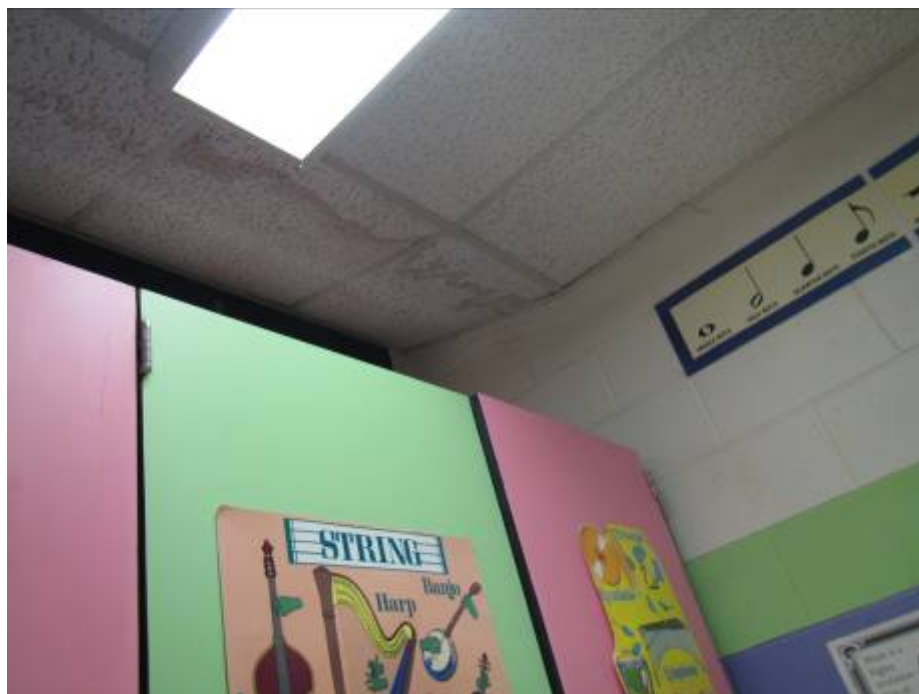
**Picture 8**

Water-damaged ceiling tiles were observed in many areas (Picture 8), reportedly from leaks from the hot water and/or steam heating system. In other areas, ceiling tiles had been removed due to water damage (Picture 9). A bucket was observed inside the ceiling plenum in a hallway to catch leaks (Picture 10). In room 6C (lower level next to the cafeteria), a ceiling tile was observed to have dark staining indicating mold growth; this stain was reported to be new as the ceiling tile had been recently changed out. This room is located in a partially below-grade area that was also of concern during the 2012 visit.

**Water-damaged ceiling tiles**

12. Make repairs to the heating system piping to prevent leaks. Replace stained and missing ceiling tiles and ensure that the ceiling plenum is complete/intact to prevent migration of particulates from above the ceiling tile system into occupied areas.

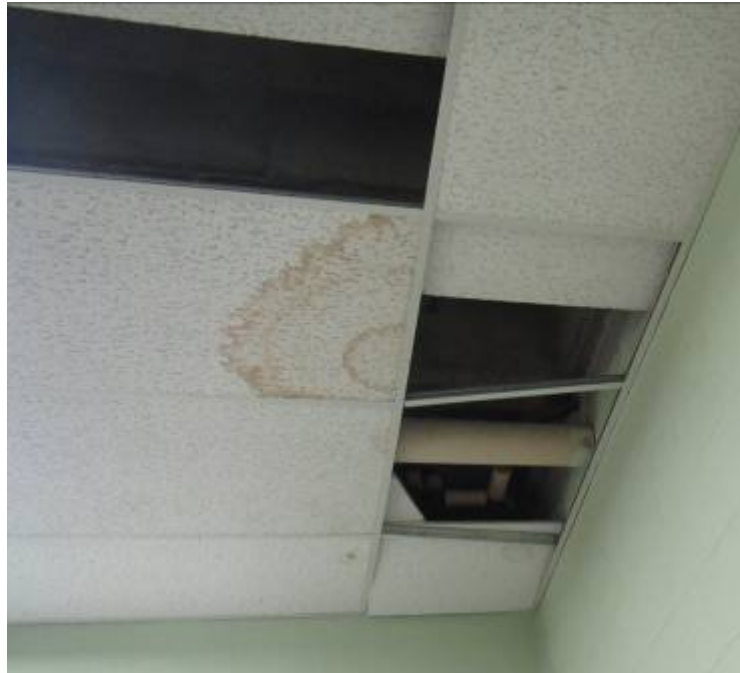
**Picture 9**

**Water-damaged ceiling tiles and missing tiles**

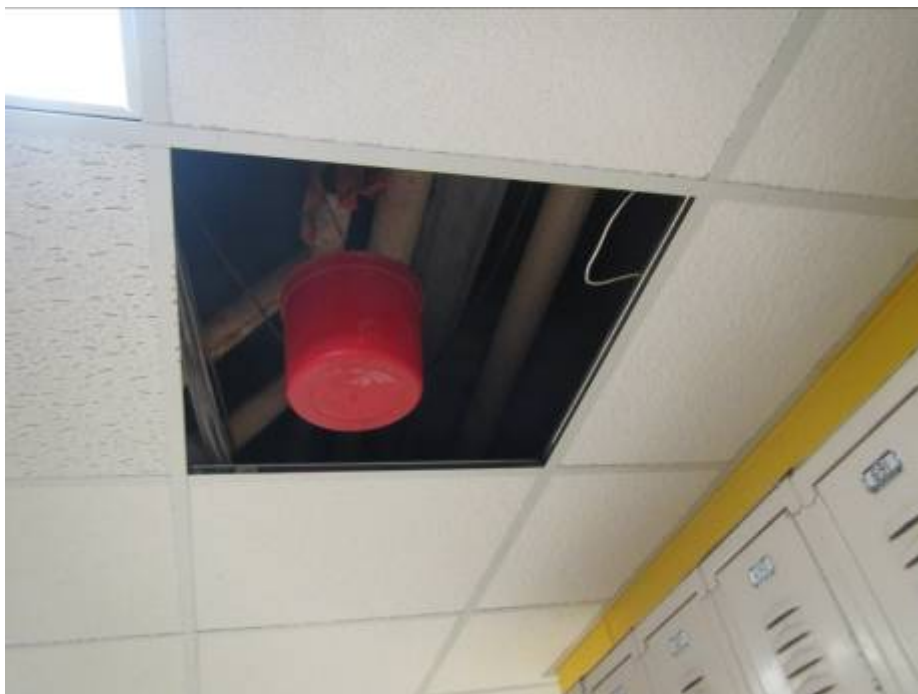
**Picture 10**

**Missing ceiling tile and bucket in hallway**

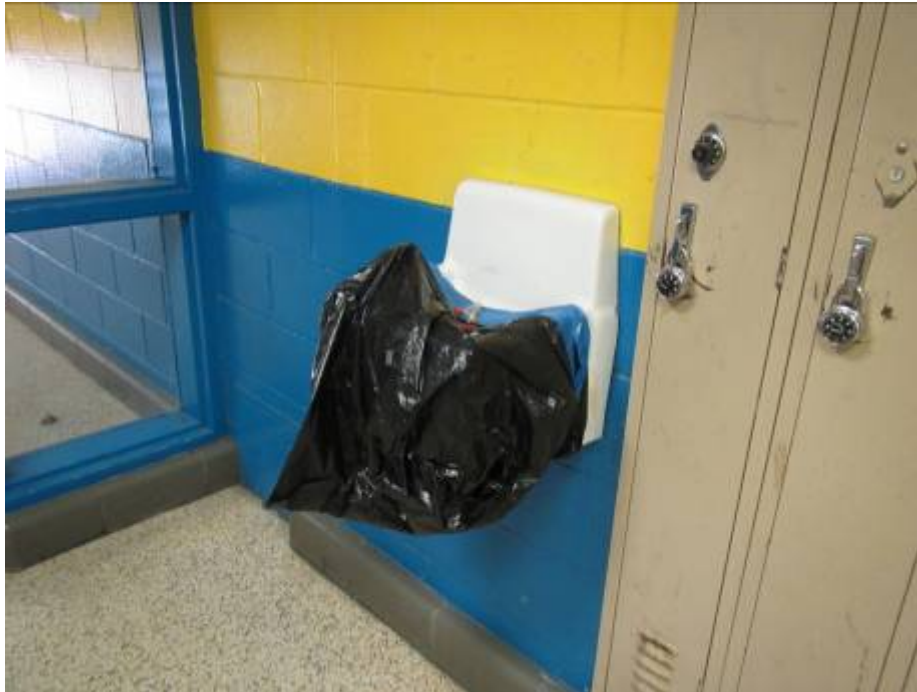
**Picture 11**

As also observed during the 2012 IAQ assessment, drinking fountains in the main hallways were found to be out of order and covered with plastic (Picture 11). In addition, lab sinks in a science classroom were covered and the cabinets beneath them were locked. It is not known if the water service to these disused fixtures had been shut off. To prevent both water leaks and the infiltration of sewer gases through unused drains, it is recommended that these fixtures be repaired or properly abandoned.

**Covered water fountain in hallway**

16. Repair broken/unused plumbing fixtures or decommission them completely.
17. Ensure indoor plants are equipped with drip pans. Examine drip pans periodically for mold growth and disinfect with an appropriate antimicrobial, as needed. Move plants away from the air stream of mechanical ventilation equipment.

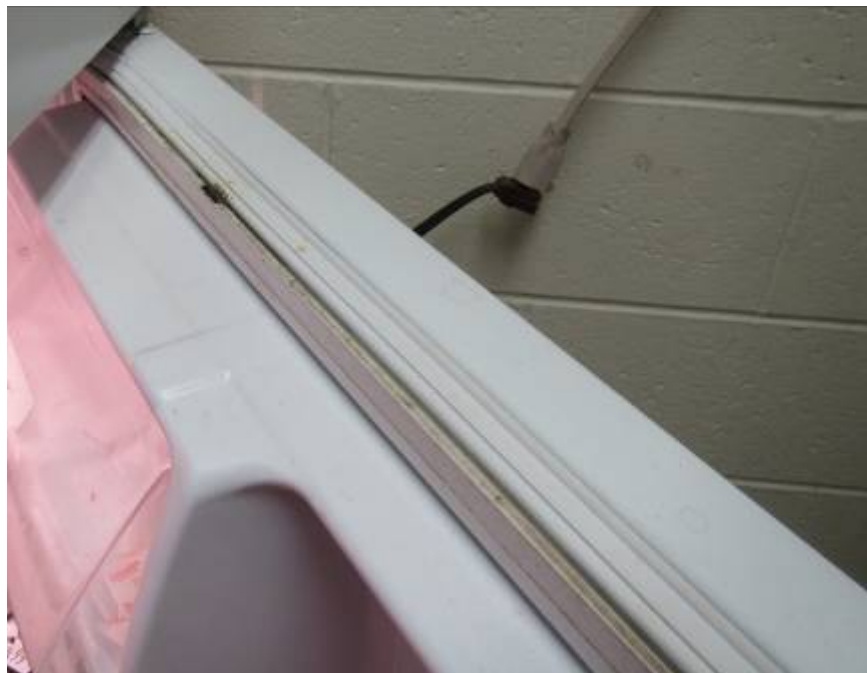
**Picture 12**

Some refrigerators examined had dark staining indicating mold growth on gaskets (Picture 12). The gaskets should be cleaned with a mild detergent or antimicrobial solution. Frequent/excessive mold staining on gaskets is an indication that the refrigerator does not seal properly and needs to be repaired/replaced.

**Refrigerator with dark staining/mold on gaskets**

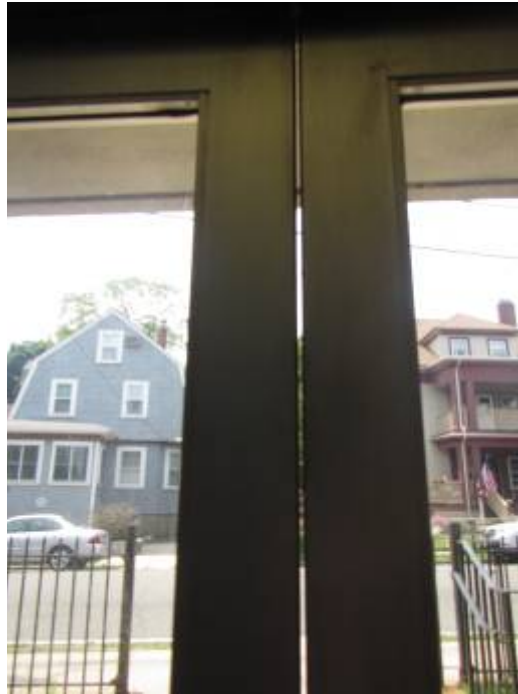
**Picture 13**

Several doors to the exterior were observed to be broken or lacking weather-stripping. These breaches can allow drafts, moisture and pests into the building (Picture 13).

**Gaps where doors to outside lack weather stripping**

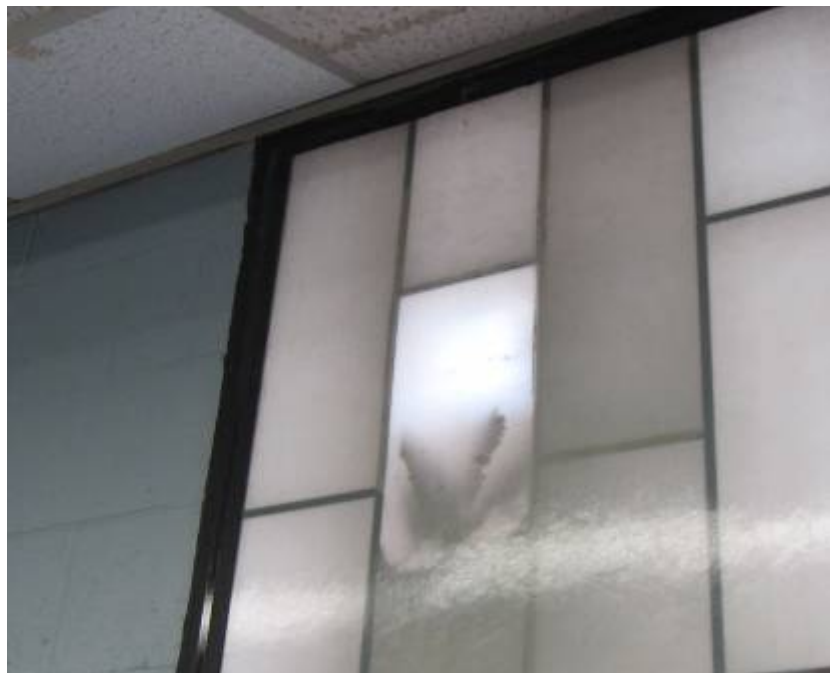
**Picture 14**

Birds were observed to be nesting inside sections of a window (Picture 14). Birds and bird wastes can be sources of allergens and microbial contamination. The birds should be removed and the windows repaired or replaced.

**Bird nesting inside window**

21. Remove birds from the window shown in Picture 14 and repair/replace the window to prevent reoccurrence.
22. Relocate or consider reducing the amount of materials stored in classrooms to allow for more thorough cleaning of classrooms. Clean items regularly with a wet cloth or sponge to prevent excessive dust build-up.
