# **INDOOR AIR QUALITY ASSESSMENT**

**Winthrop Elementary School  
65 Central Street  
Ipswich, Massachusetts 01938**

Prepared by:  
Massachusetts Department of Public Health  
Bureau of Environmental Health  
Indoor Air Quality Program  
October 2009

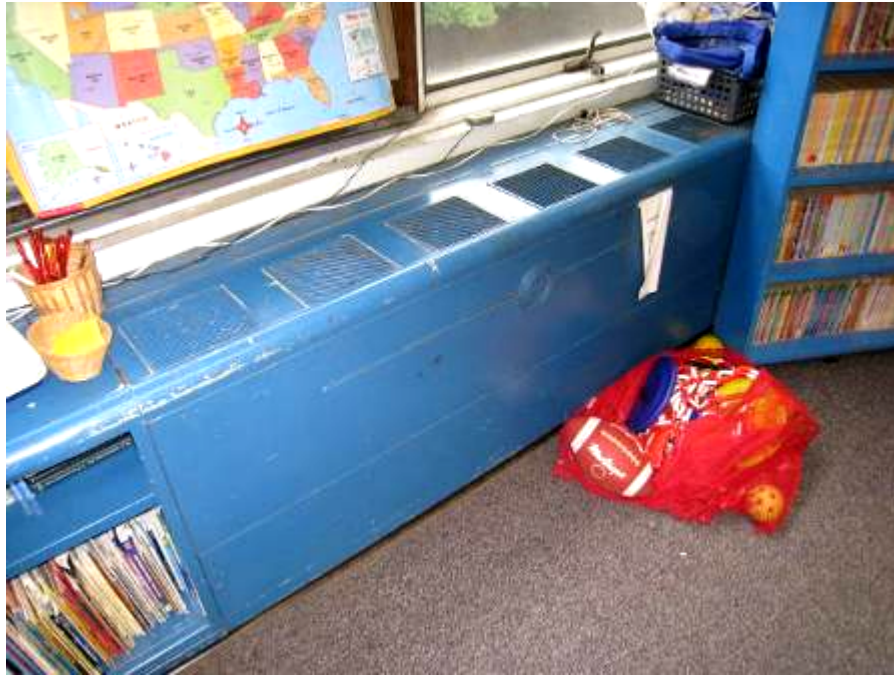
**Picture 1**

Fresh air for classrooms is supplied by unit ventilator (univent) systems (Picture 1). A univent draws outdoor air through a fresh air intake located on the exterior wall of the building (Picture 2), and return air from the room through an air intake located at the base of the unit ([Figure 1](#)). Fresh and return air are mixed, filtered, heated and distributed to the room through an air diffuser located in the top of the unit. Univents were operating in the majority of rooms at the time of the assessment; however, BEH staff found several univents switched 'off', preventing fresh air from being introduced into these rooms. Univent air diffusers and returns were blocked by furniture and other stored items in front and on top of the unit, thereby limiting airflow in these rooms. In one area, the univent had a missing panel exposing the interior of the unit (Picture 3). In order for univents to provide fresh air as designed, air diffusers, intakes and returns must remain free of obstructions. Importantly, these units must remain "on" and be

**Classroom Univent**

1. Operate all ventilation systems throughout the building *continuously* during periods of school occupancy. To increase airflow in classrooms, set univent controls to “high”. School staff should be encouraged not to deactivate classroom univents; rather, report any complaints to the facilities department.

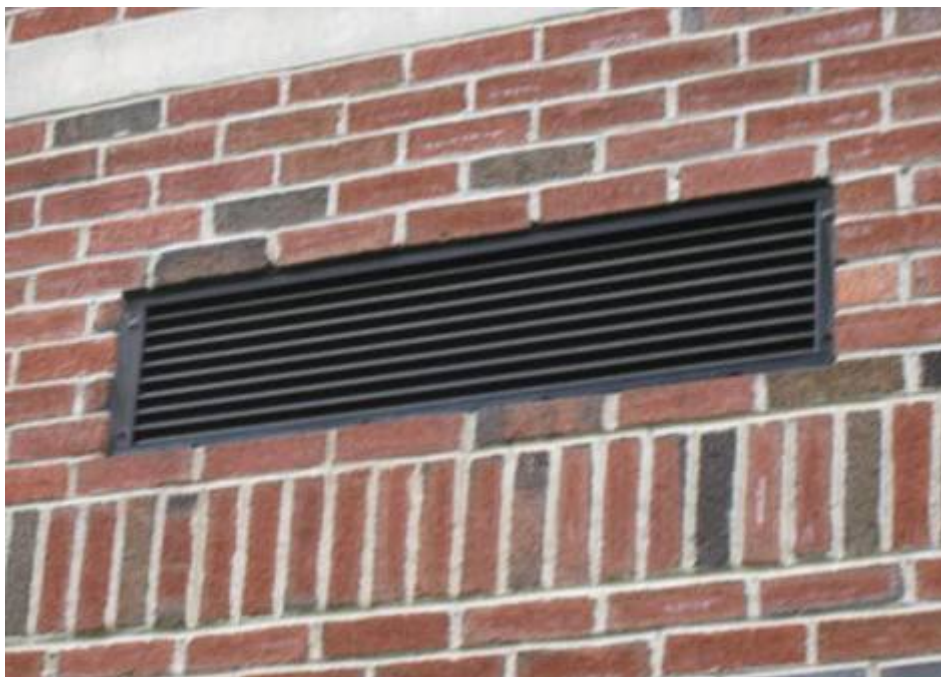
**Picture 2**

**Univent Fresh Air Intake on Exterior Wall**

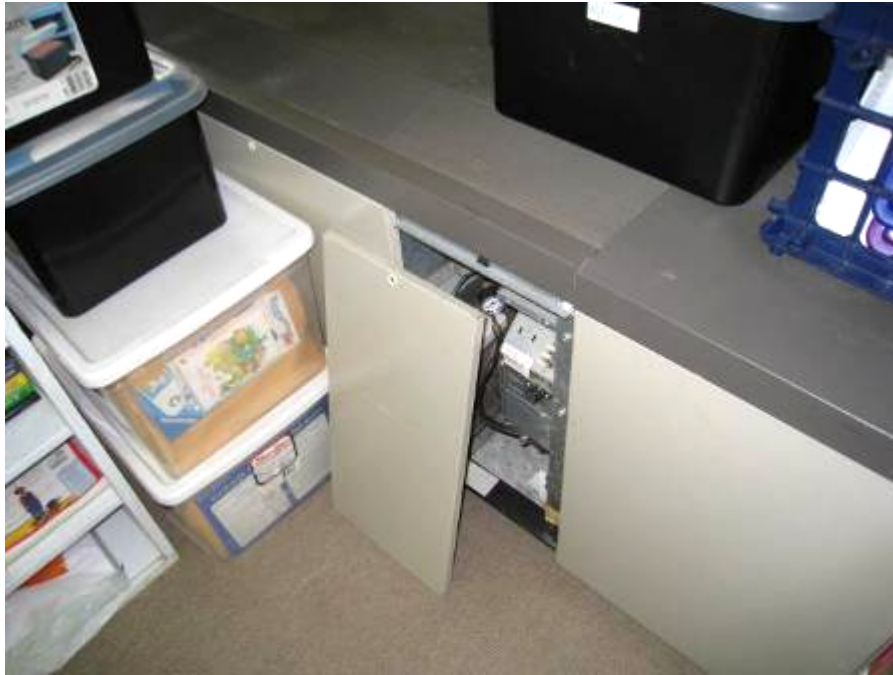
**Picture 3**

**Stored Items on Top and in Front of Univent, Note Panel Removed**

2. Inspect all exhaust motors and belts periodically for proper function. Repair and replace as necessary.
3. Remove all blockages from univents and exhaust vents to ensure adequate airflow.

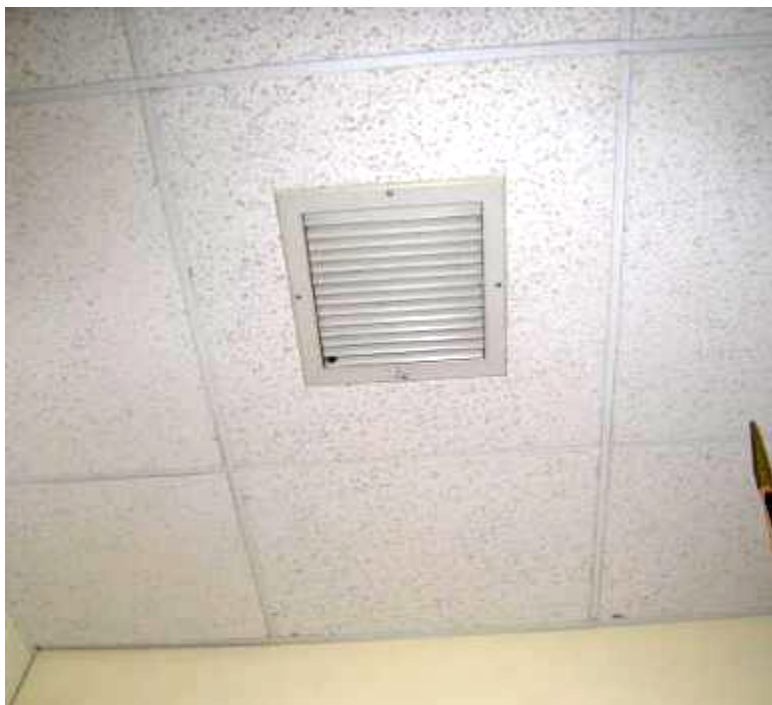
**Picture 4**

Exhaust ventilation is provided by vents ducted to rooftop motors. Exhaust vents at the WES are located on the ceiling, wall, or at the top of storage closets/shelving (Pictures 4 through 7). Exhaust ventilation systems continuously remove air that has become stale from moisture, odors, and pollutants. In order to function properly, exhaust vents must be activated and allowed to operate without obstruction while rooms are occupied. Without adequate exhaust ventilation, excess heat and stale air can build up leading to indoor air quality and comfort complaints. The work room is not equipped with exhaust ventilation. This area contains photocopiers and a lamination machine each of which can be a source of pollutants such as heat and odors, particularly if the equipment is older and in frequent use.

**Exhaust Vent on Ceiling**

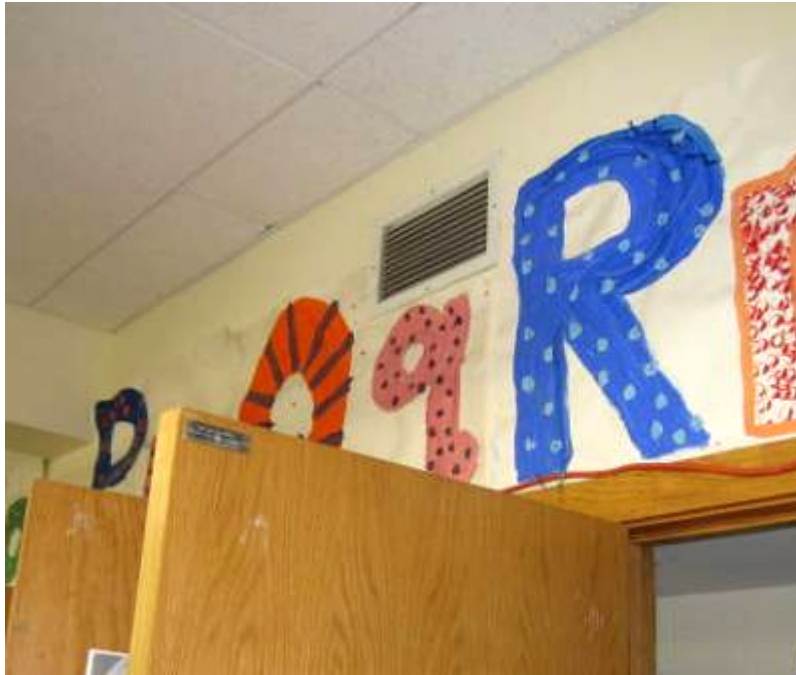
**Picture 5**

**Exhaust Vent on Wall**

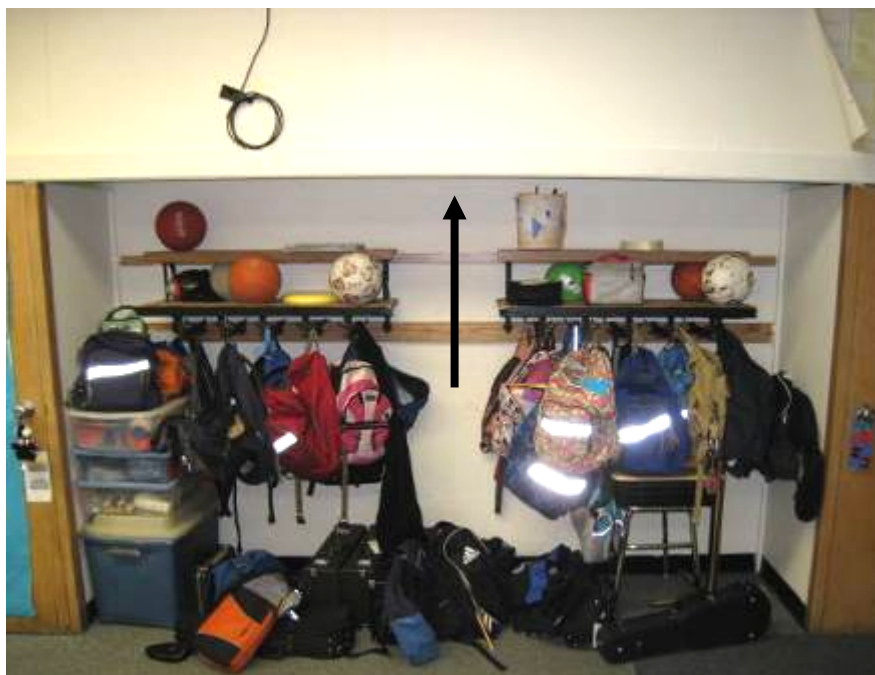
**Picture 6**

**Exhaust Vent in Storage Closet**

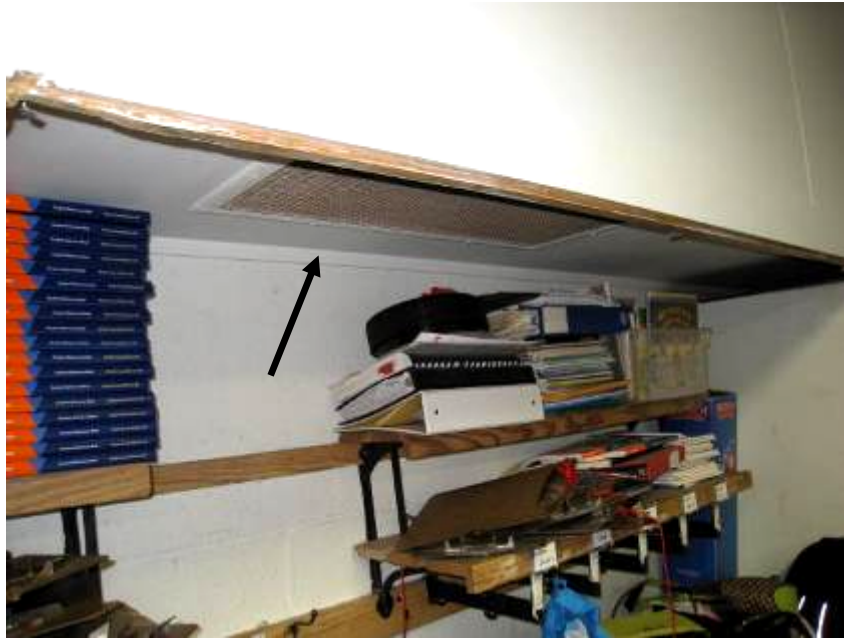
**Picture 7**

**Exhaust Vent in Classroom Shelving**

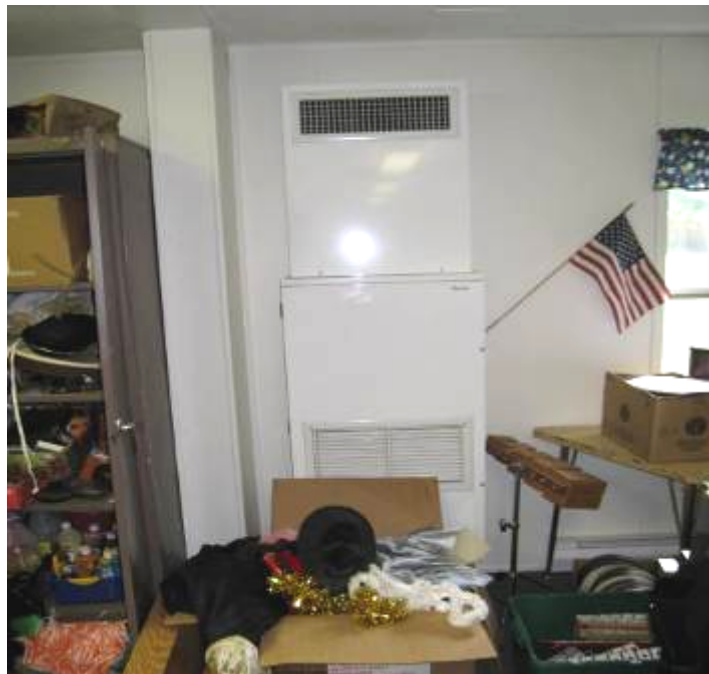
**Picture 8**

Wall-mounted air handling units (AHUs) provide ventilation for the modular classroom wing (Picture 8). The modular wing houses three rooms; however, only two AHUs exist. One room lacks mechanical ventilation; therefore, windows and an exterior door are the only means of introducing fresh air to this area. AHUs draw fresh air through an air intake on the exterior of the modular classroom and then distribute it to the room through an air diffuser at the top of the AHU. Stale air from the room is returned to the AHU through a vent at the base of the unit to an exhaust vent on the building exterior. Thermostats that control the AHU system in the modular classrooms have fan settings of “on” and “automatic”. The “automatic” setting on the thermostat activates the AHU system at a preset temperature, and then deactivates the system once the preset temperature is reached. In the fan “on” setting, the AHU system provides continuous airflow to the rooms.

**Air Handling Unit on Wall in Modular Classroom  
Air Diffuser at Top, Exhaust Vent at Base**

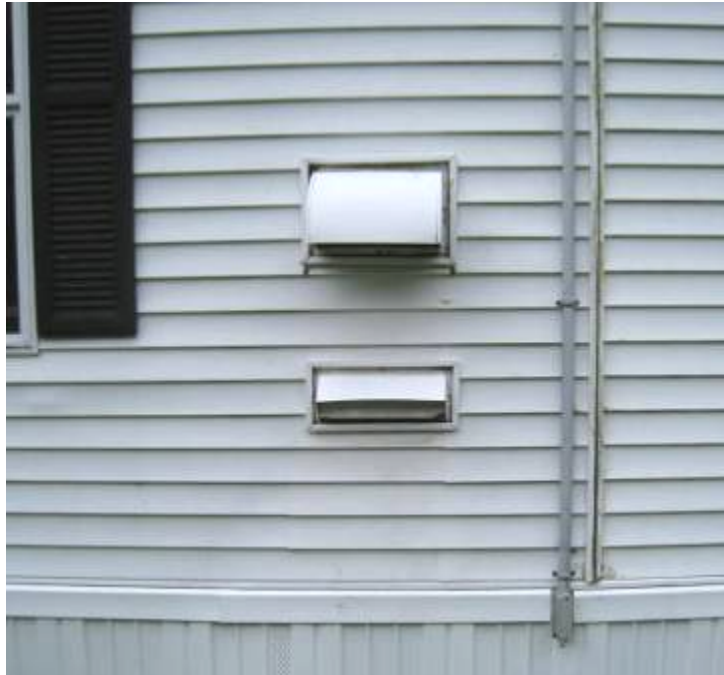
**Picture 9**

On the exterior wall of the modular classroom, the fresh air intake is directly above the exhaust vent (Picture 9). The configuration of the intake and vent is problematic since pollutants that are exhausted from the classroom can be brought back inside via the air intake. The exhaust vent should be ducted away from the fresh air intake. BEH staff also found the fresh air intakes coated with accumulated dust and debris (Picture 10).

**Air Intake Directly Above Exhaust Vent on Exterior Wall**

6. Duct exhaust vents away from fresh air intakes on exterior wall of modular classrooms.
7. Clean accumulated dust and debris from fresh air intakes on exterior wall of modular classrooms.

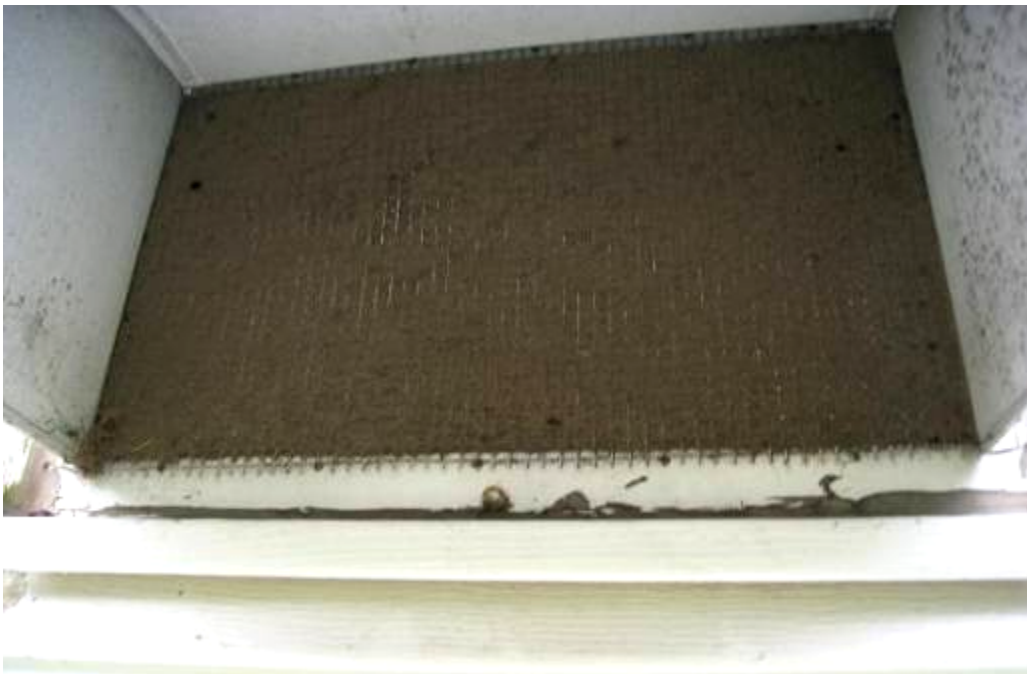
**Picture 10**

**Accumulated Dust and Debris on Air Intake**

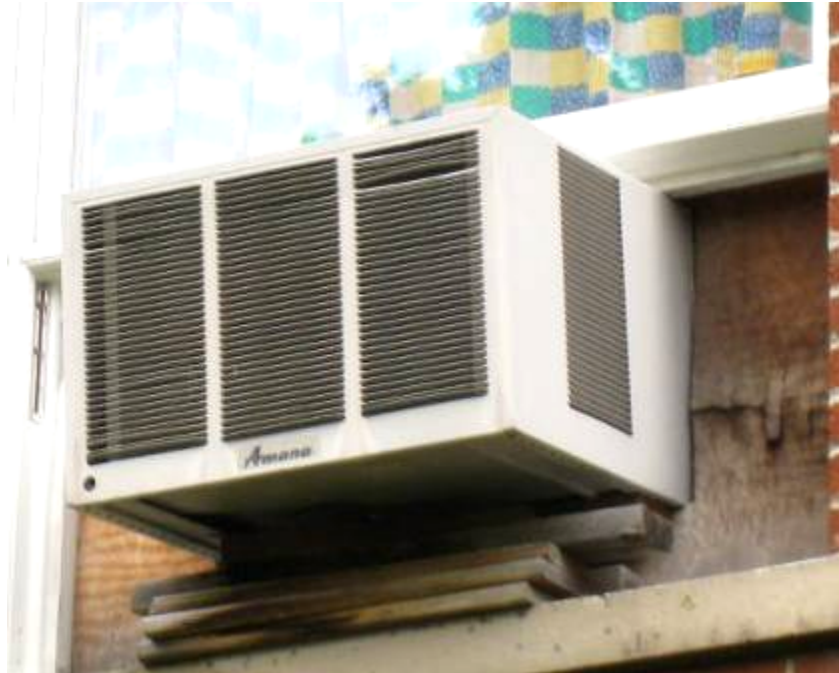
**Picture 11**

Air conditioners (AC) were used in several rooms (Pictures 11 and 12). ACs are normally equipped with filters, which should be cleaned or changed as per manufacturers' instructions to avoid the build-up and re-aerosolization of dirt, dust and particulate matter.

**Air Conditioner in Window**

9. Change filters for air-handling equipment (e.g., univents, AHUs and ACs) as per the manufacturer’s instructions or more frequently if needed. Vacuum interior of units prior to activation to prevent the aerosolization of dirt, dust and particulates. Ensure filters fit

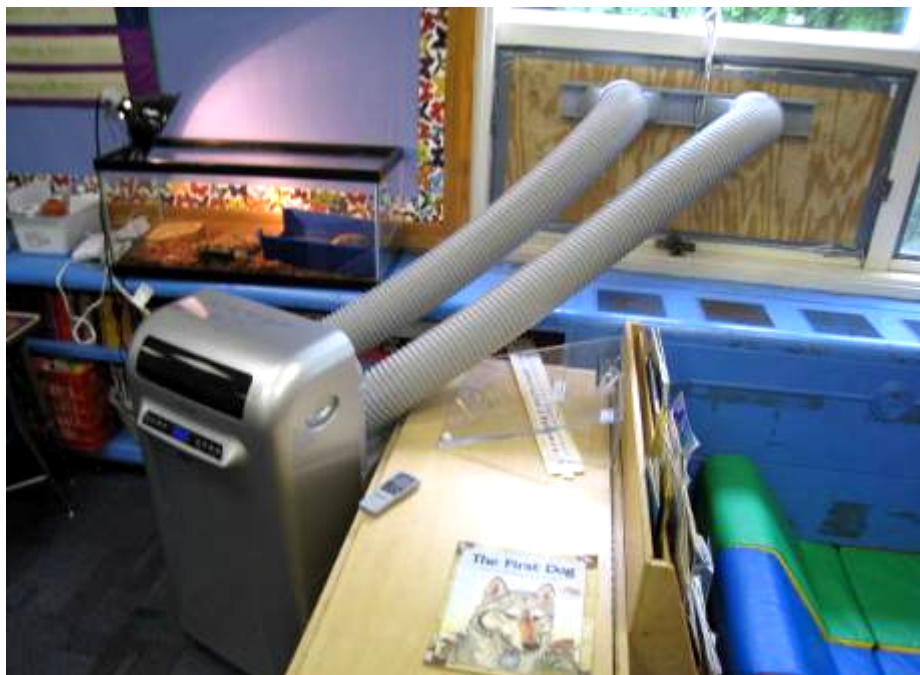
**Picture 12**

**Air Conditioner Ducted to Window by Hoses**

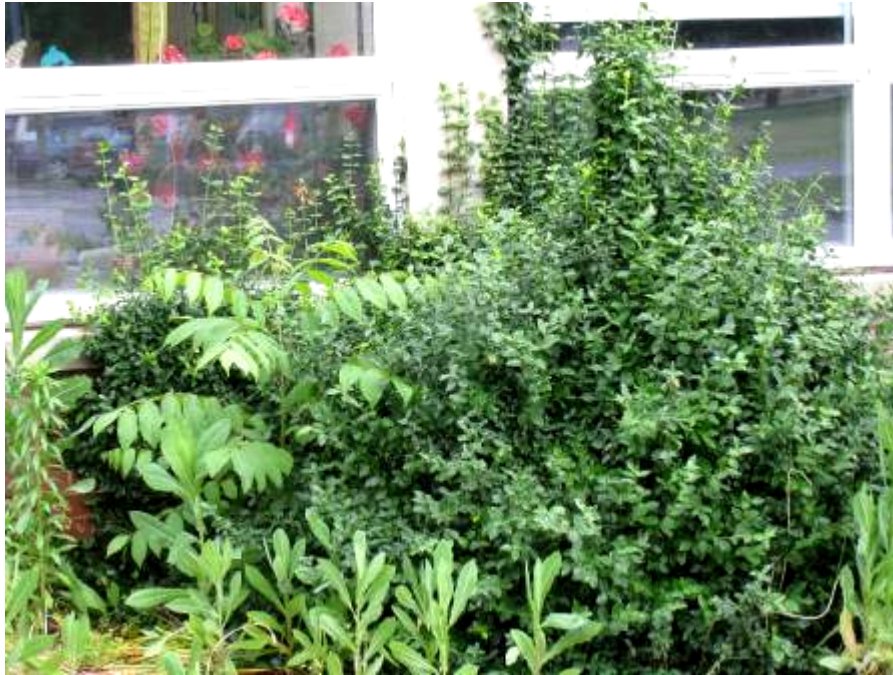
**Picture 13**

- Shrubs and trees growing against the building, holding moisture against exterior brick (Pictures 13 through 15);
- Plants and shrubs growing in front of fresh air intakes allowing moisture-laden air to be drawn in by the fresh air intake (Pictures 15 through 17); and,
- Exterior brick was damaged and water stained indicating a heavy and/or continuous water exposure (Pictures 18 and 19).

**Shrubs Growing Against Building**

11. Cut shrubs and trees in a manner to maintain a space of 3 feet from the building exterior and univent fresh air intakes, to prevent moisture from being held against exterior brick and moisture-laden air to be drawn in by the fresh air intake.

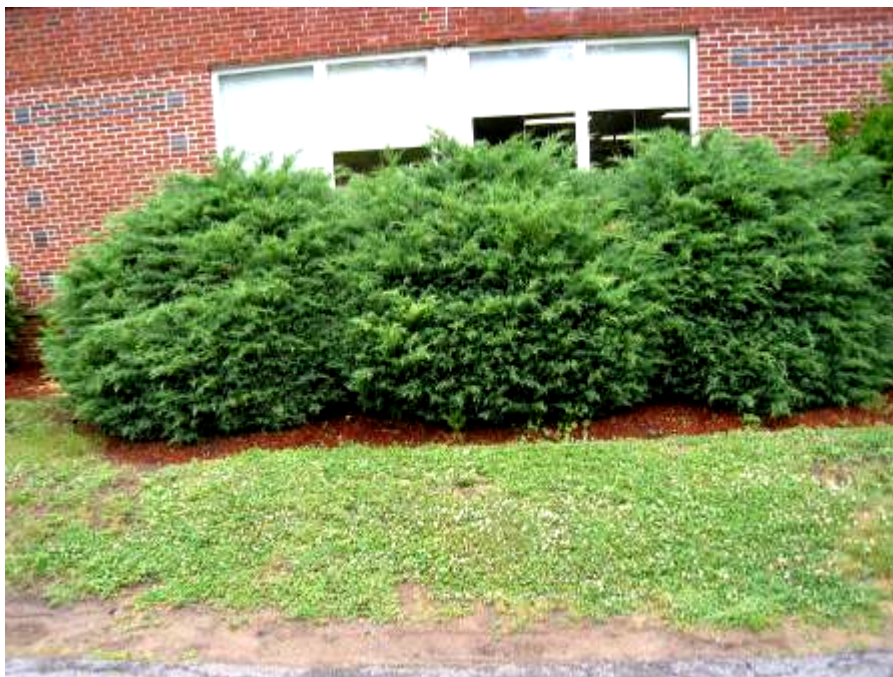
**Picture 14**

**Shrubs Growing Against Building**

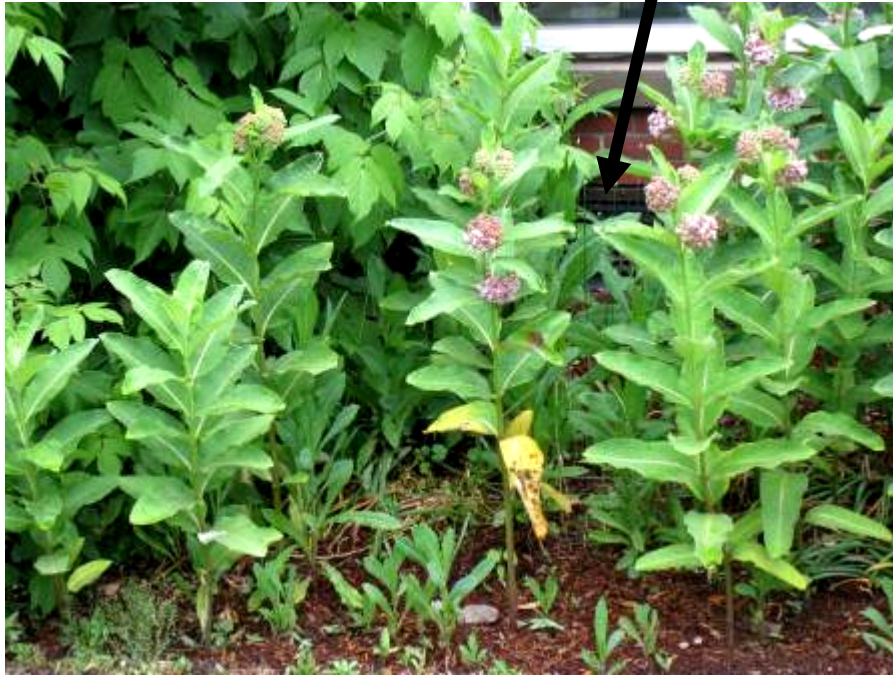
**Picture 15**

**Plants and Shrubs Growing in Front of Fresh Air Intake**

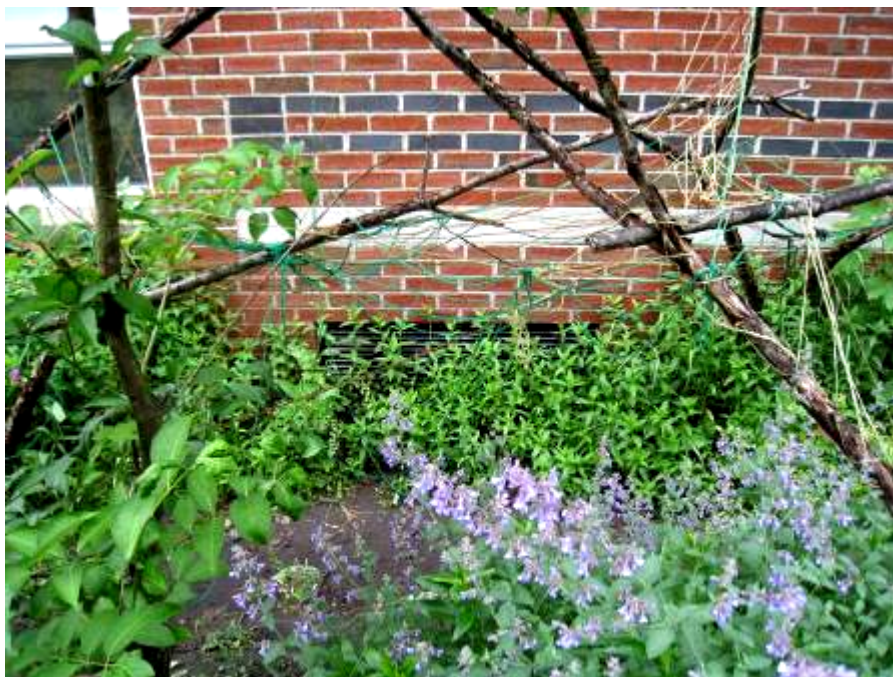
**Picture 16**

**Plants Growing in Front of Fresh Air Intake**

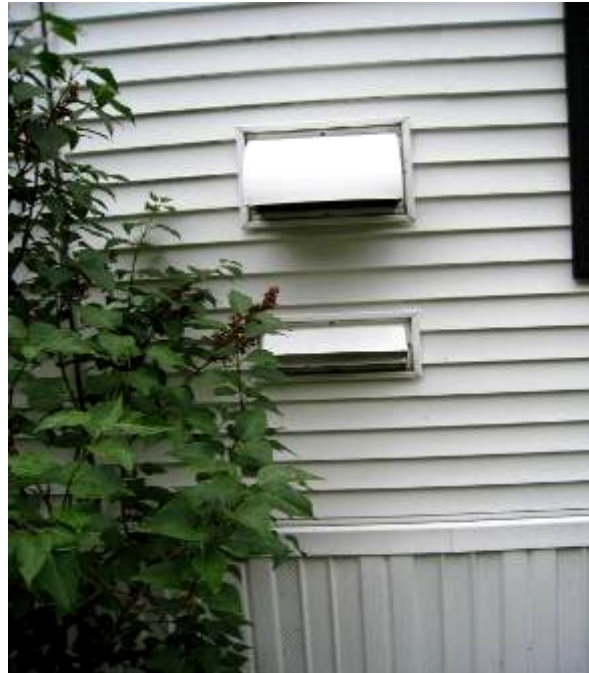
**Picture 17**

**Shrubs Growing near Fresh Air Intake**

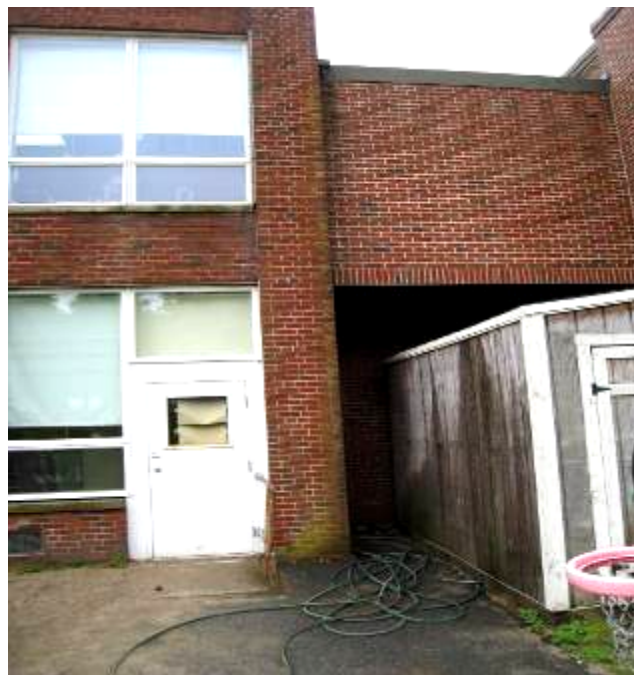
**Picture 18**

These conditions indicate that water has penetrated through the building envelope. Moisture laden air can infiltrate through breaches and condense on building materials. A heavy and/or continuous water exposure to the building exterior can undermine the integrity of the building

**Water Stains on Exterior Brick and Storage Shed**

12. Consider having exterior walls re-pointed and waterproofed to prevent water intrusion. This measure should include a full building envelope evaluation.

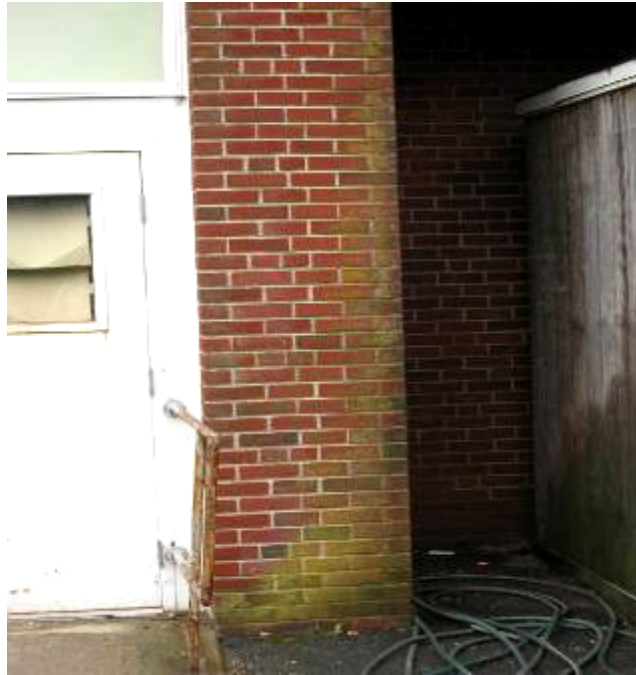
**Picture 19**

**Water Stains on Exterior Brick**

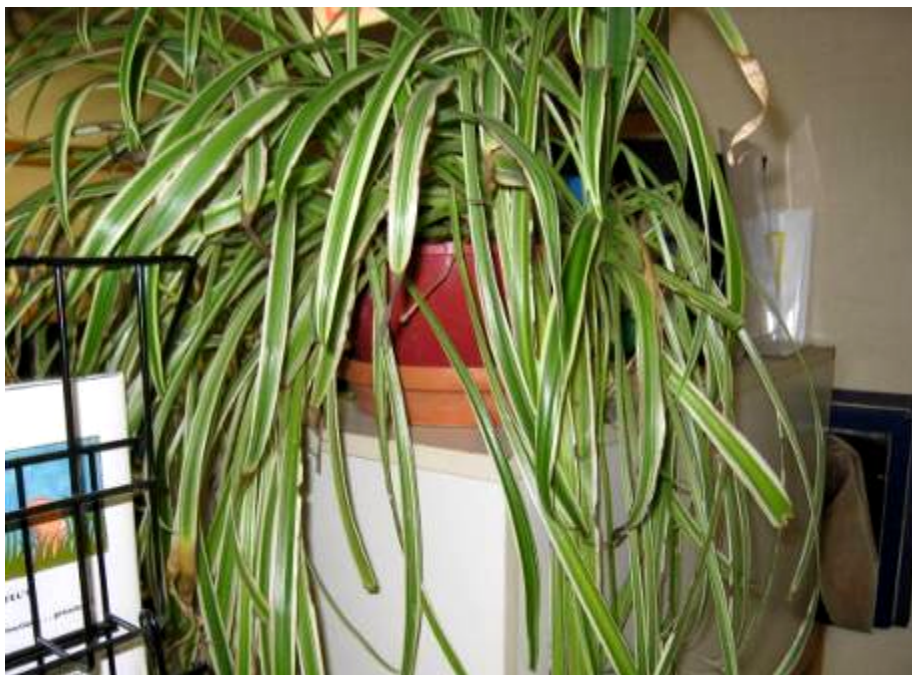
**Picture 20**

A number of classrooms had plants (Picture 20). Plants can be a source of pollen and mold, which can be respiratory irritants for individuals. Plants should be properly maintained and equipped with drip pans to prevent water damage to porous building materials, which can lead to mold growth. Plants should also be located away from ventilation sources (e.g., air intakes, univent diffusers) to prevent the entrainment and/or aerosolization of dirt, pollen or mold.

**Plants in Classrooms**

14. Move plants away from univents in classrooms. Avoid over-watering and examine drip pans periodically for mold growth. Disinfect with an appropriate antimicrobial where necessary.

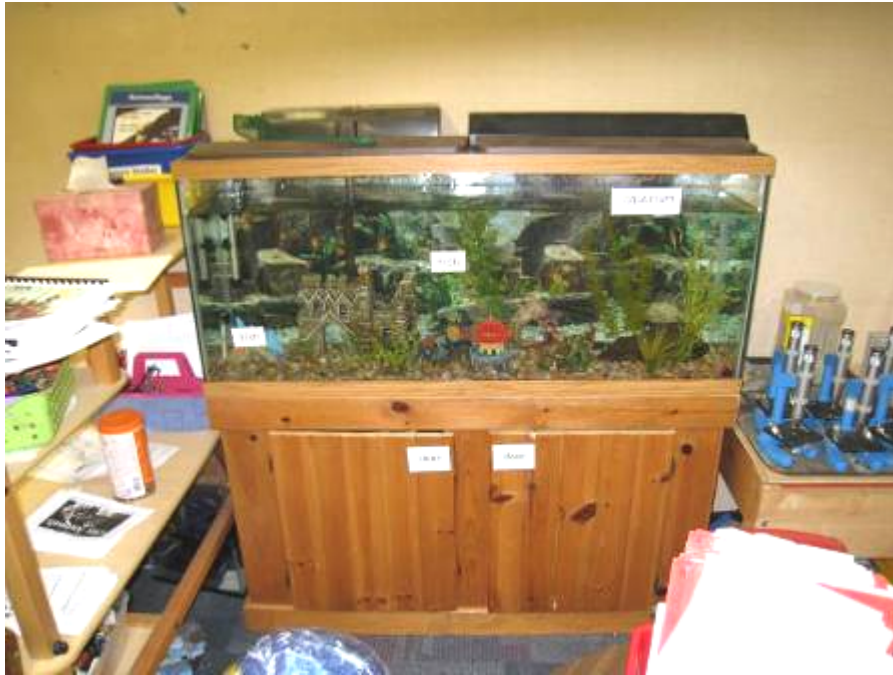
**Picture 21**

Aquariums were also located in a number of classrooms (Picture 21). Aquariums should be properly maintained to prevent microbial/algae growth, which can emit unpleasant odors.

**Aquarium in Classrooms**

15. Clean and maintain aquariums and animal cages to prevent mold growth and associated odors.

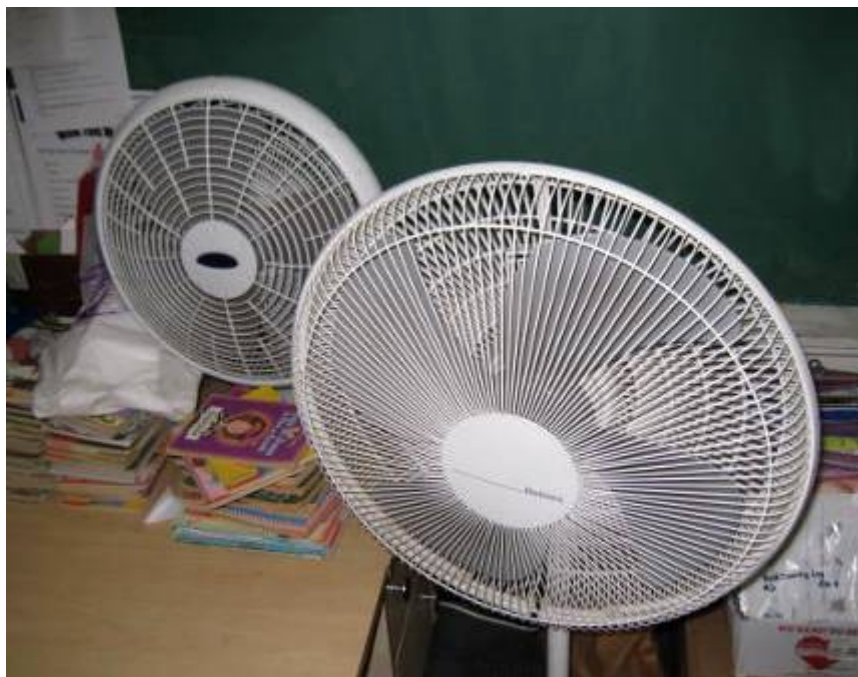
**Picture 22**

A number of univent/supply air diffusers, exhaust vents and personal fans in classrooms were observed to have accumulated dust/debris (Picture 22). Re-activated supply vents/fans can aerosolize dust accumulated on fan blades/housing. If exhaust vents are not functioning, backdrafting can occur, which can re-aerosolize dust particles.

**Accumulated Dust and Debris on Fan Blades**

18. Clean accumulated dust and debris periodically from univent air diffusers, exhaust vents and blades of personal fans.
19. Consider adopting the US EPA (2000) document, "Tools for Schools", as an instrument for maintaining a good indoor air quality environment in the building. This document is available at: <http://www.epa.gov/iaq/schools/index.html>.

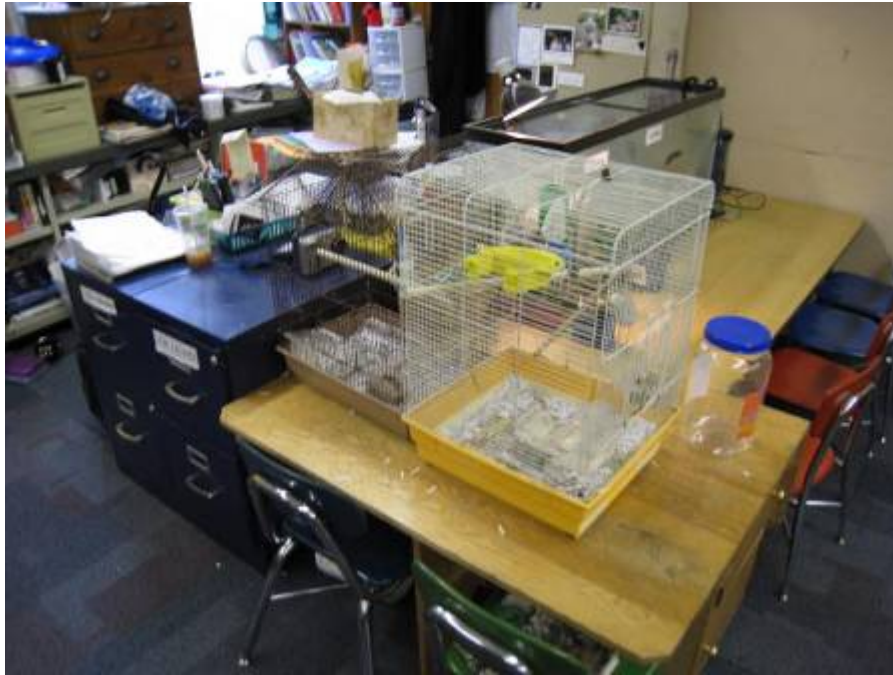
Picture 23

Lastly, a classroom had a pet bird who was housed in a cage (Picture 23). Animal dander, fur and wastes can all be sources of respiratory irritants. Animal cages should be cleaned regularly to avoid the aerosolization of allergenic materials and/or odors.

Bird in Classroom
